# SCVWD UPPER PENITENCIA CREEK (KAMMERER) PROPERTY 2017 ANNUAL REPORT

## YEAR 3

Prepared by:

January 16, 2018

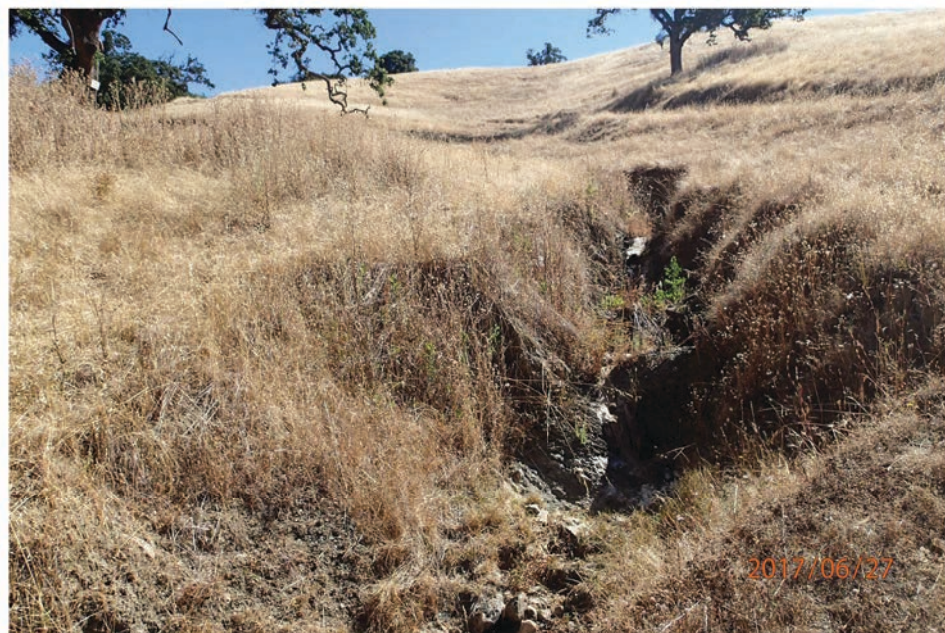
1 Headcut below Roadway at Station 1.JPG

Cattle disturbance was not observed at this station, however they were seen just downstream of this site. The stream banks were unstable and had either exposed soil or bedrock. The areas with bedrock will stabilize the banks. Wash out from the road contributed to a large headcut (approximately 10' deep) near the roadway. The conditions at this site were similar to baseline conditions observed in 2014 and to conditions observed in 2016. The site should continue to be monitored to ensure the headcut and gullies do not increase in size. Re-directing runoff away from the road should be considered. The culvert located downstream of the monitoring station was cleaned out in 2015 and is functioning, which helped protect the road this winter.

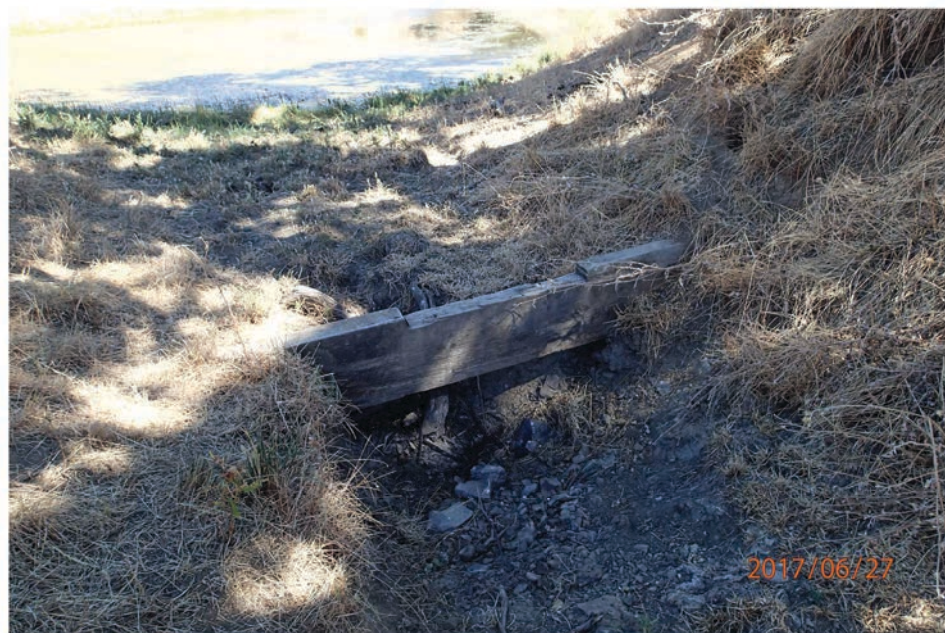
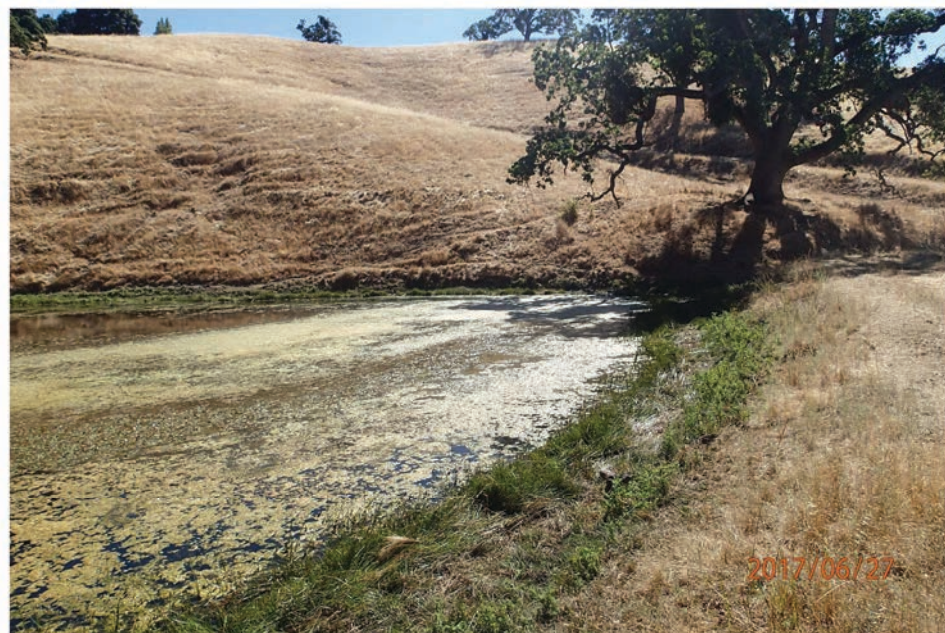
Recent cattle disturbance was observed with cow pies on the dam. The cattle trails around the pond are more evident than in 2016. The wetland vegetation at the inlet of the pond and around the pond perimeter has decreased from 2016, but increased from baseline conditions in 2014. The condition of the pond should continue to be monitored. If conditions continue to decrease partial fencing of the pond should be explored.

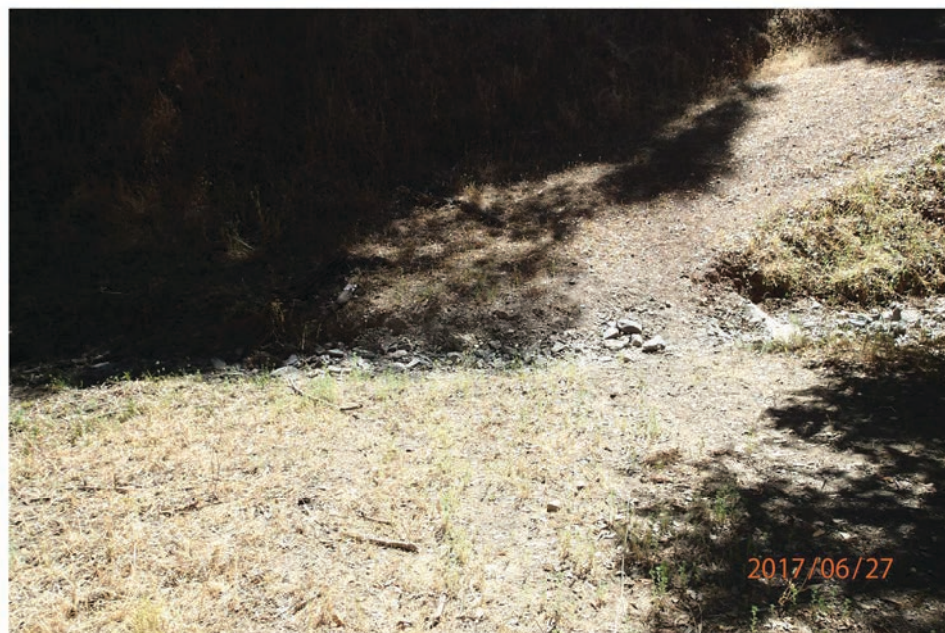
13 Rut in Road.JPG

Moderate amounts of cattle disturbance and erosion was noted. Conditions were similar to 2014 - 2016. Sections of the banks were undercut, although rocks and tree roots provide some stability. The 6-12 inch rut in the roadway had not increased since 2014 despite the winter storms. The site should continue to be monitored.
