# SCVWD UPPER PENITENCIA CREEK (KAMMERER) PROPERTY 2017 ANNUAL REPORT

## YEAR 3

Prepared by:

January 16, 2018

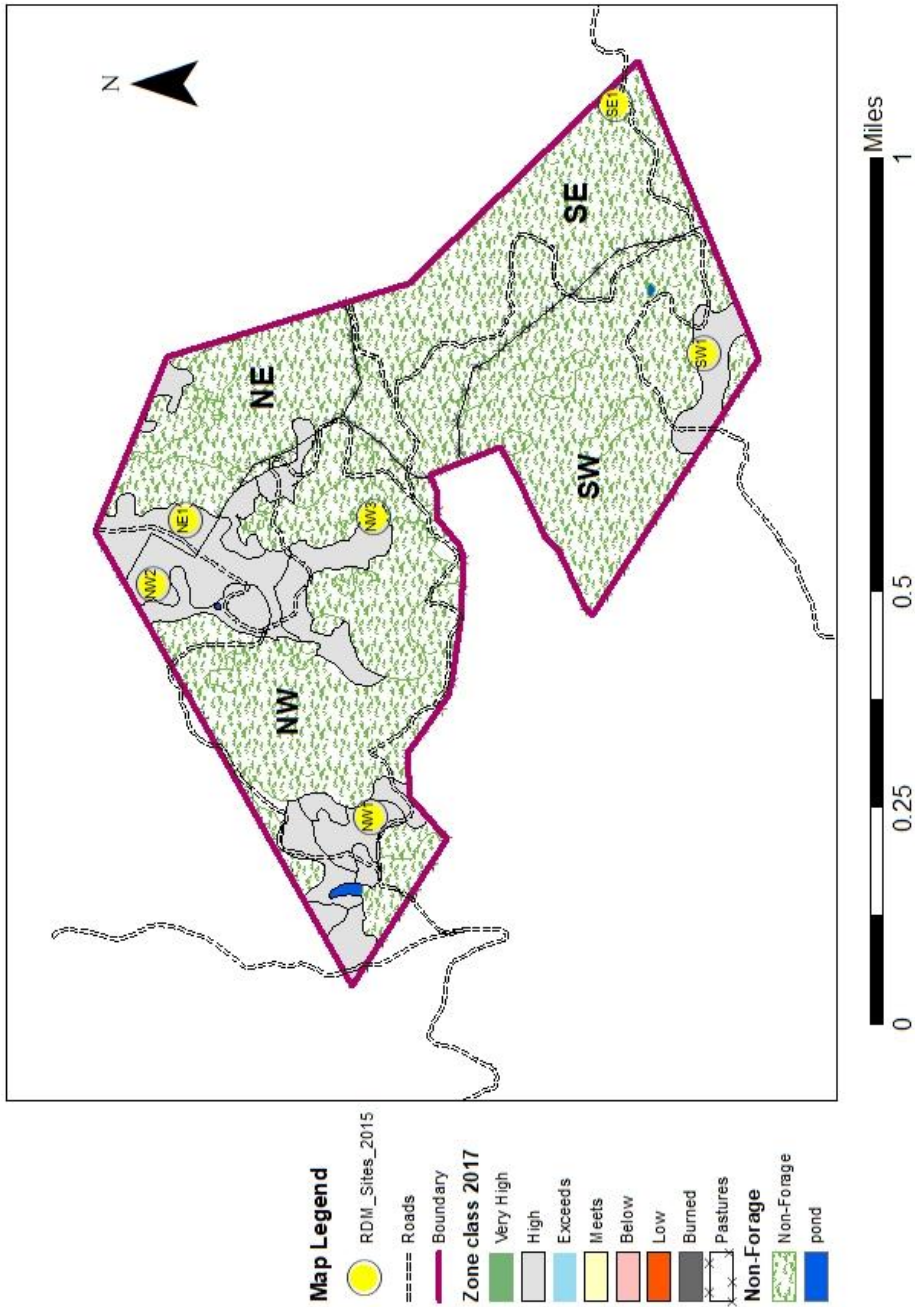
**Figure 2: RDM Zones 2017  
Upper Penitencia Property**

The RDM Zone map, Figure 2, for 2017 shows how well various portions of the SCVWD – Upper Penitencia Property met the established RDM objectives for each portion of the property.

**Meets RDM** levels were not of significant size to be mapped in 2017, including the small area in the South-East MU where monitoring site SE-1 is located.

**Below RDM** objectives were not recorded in 2017.

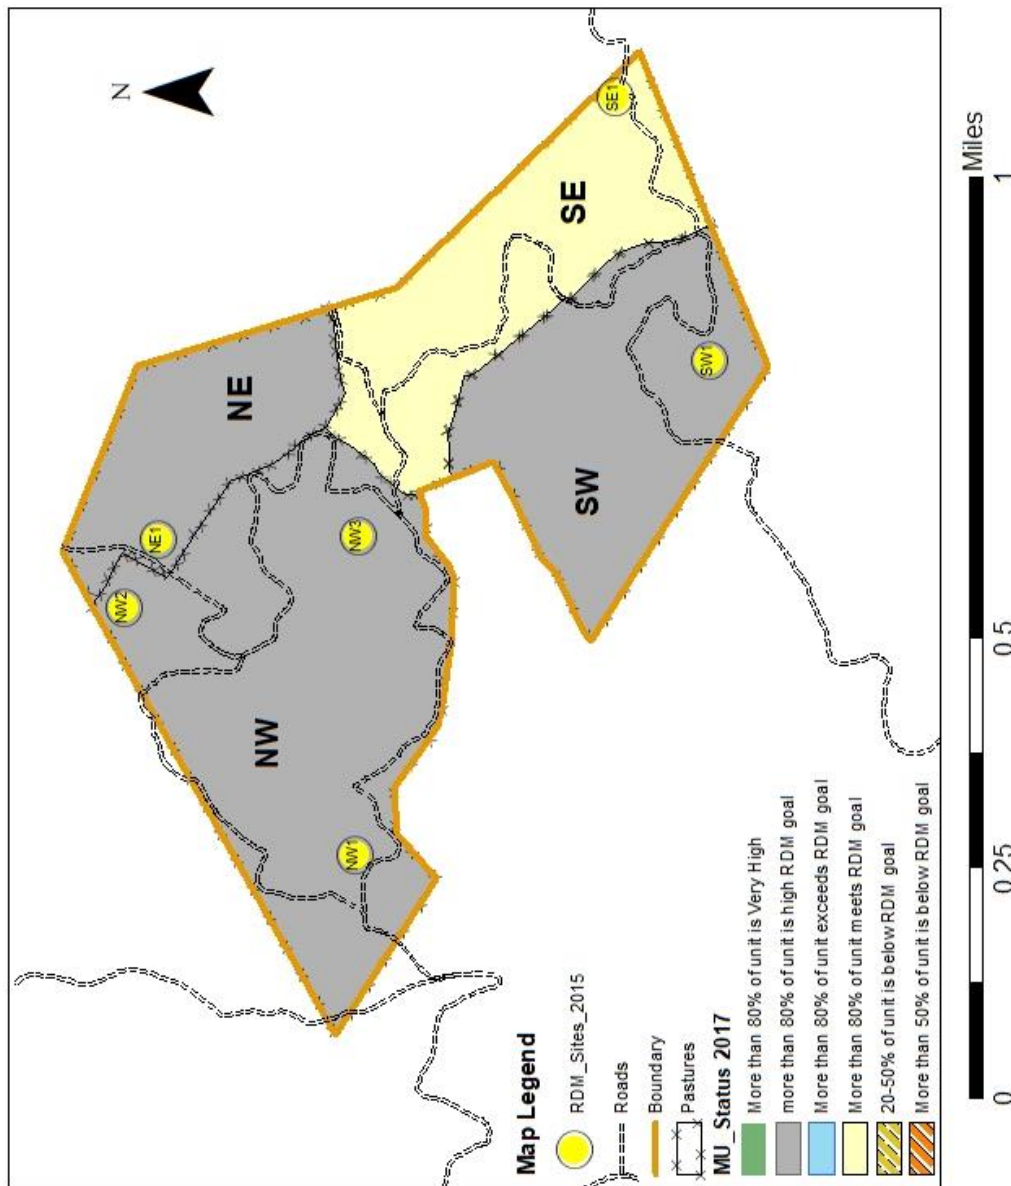
**Figure 3: MU Status 2017  
Upper Penitencia Property**

Figure 3 for 2017 shows that:

There were 3 Grazing subunits with more than 80% of the subunit estimated to have **High RDM** levels, subunits NE, NW and SW. These three subunits received only incidental livestock use in 2017.

The SE subunit is predominately oak woodland, had only incidental livestock use, and was found to have more than 80% of the subunit estimated to **Meet RDM** levels due to the inherent low productivity of the few forage areas.

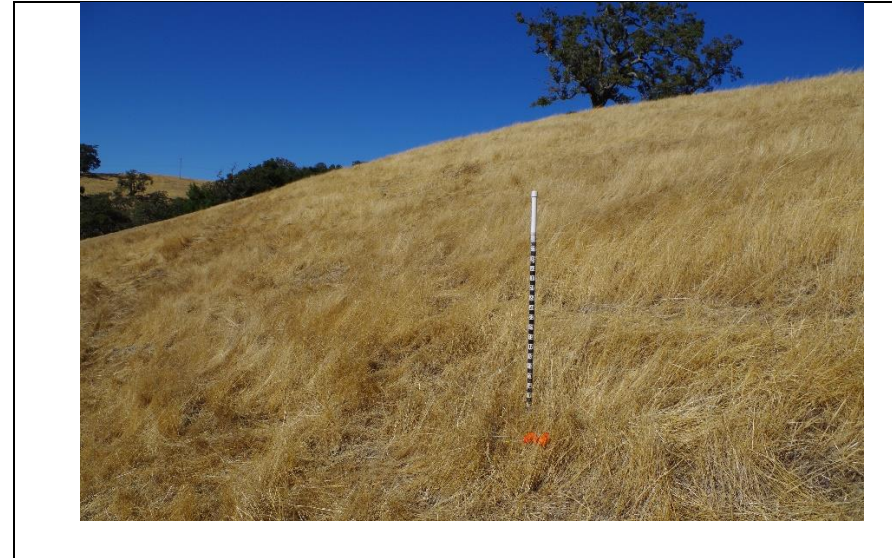
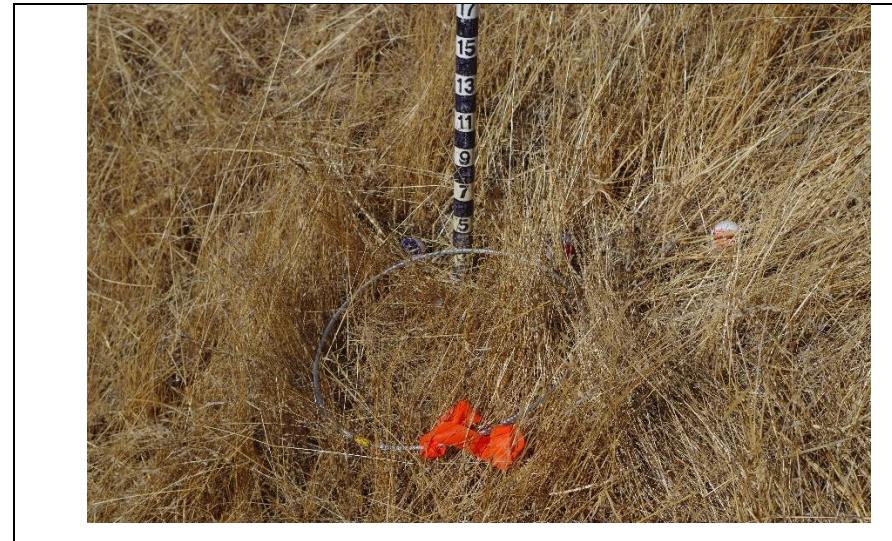
**Monitoring Site #**NW1

Clipped 2800 lbs/acre RDM

RDM varies 2000-3500 lbs/acre

**Slope:** 42 %      **Aspect:** SW  
**Residual Dry Matter Objective:** 1000-1500  
**RDM Class When Surveyed:** High

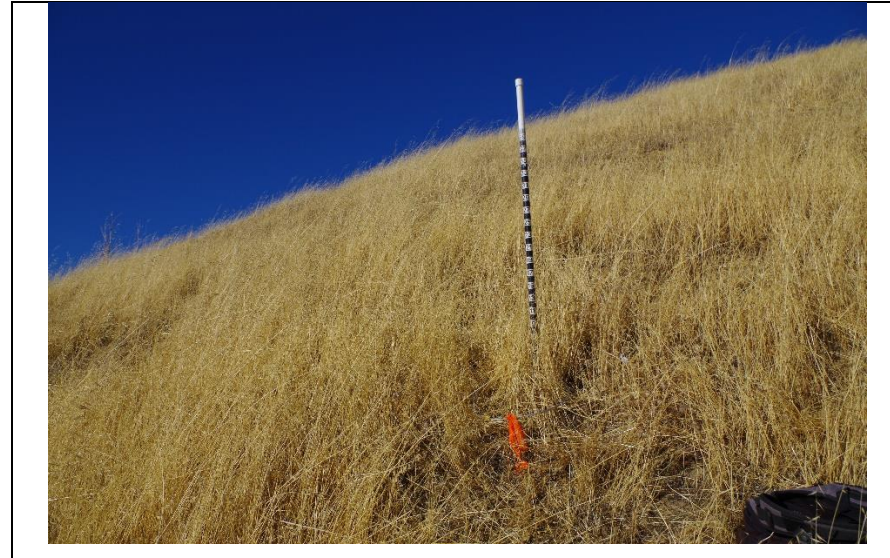
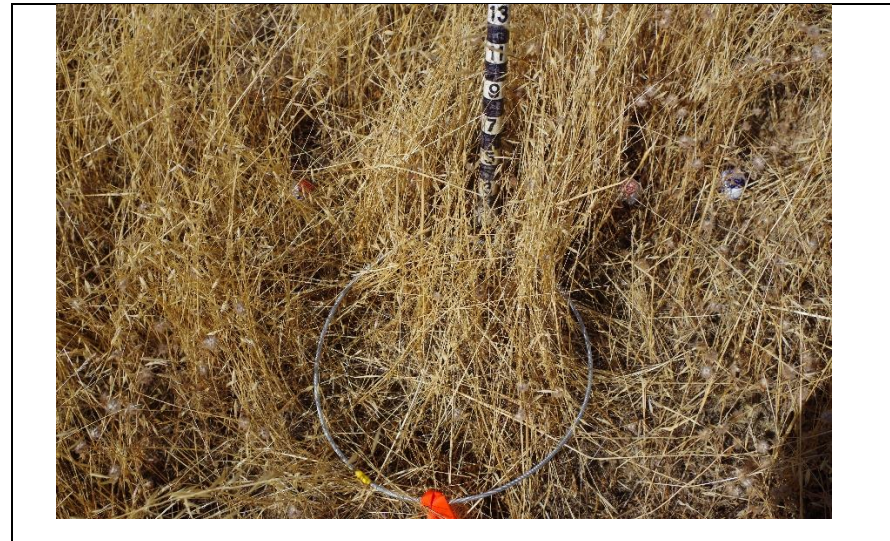
**Monitoring Site #NW2**

RDM varies 2200-3,200 lbs/acre

RDM clipped 2,900

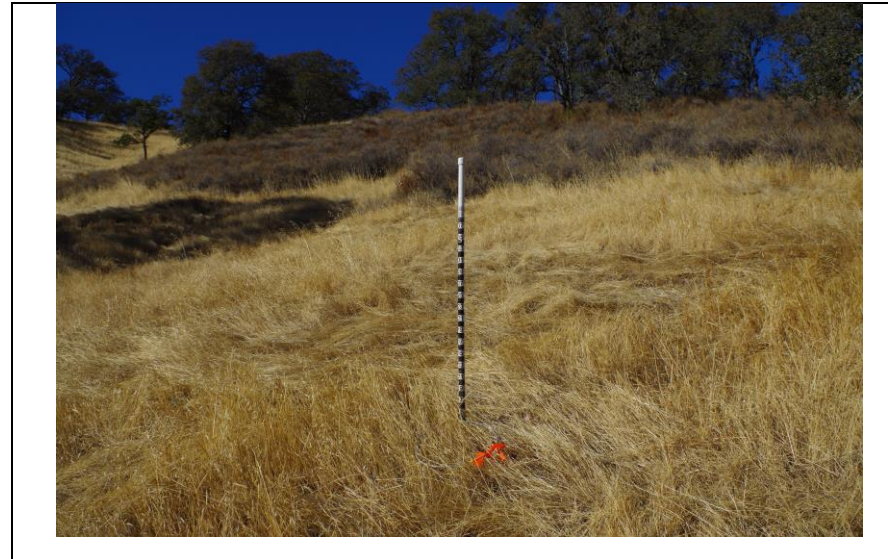
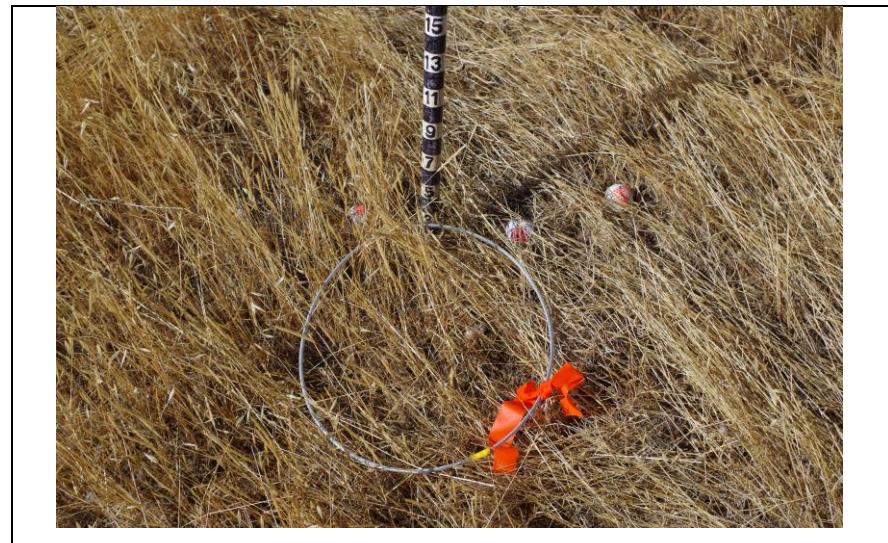
**Monitoring Site #NW3**

Most of grassland area in the vicinity is 2,000-2500 lbs/acre

Average for area is 2,300 lbs/acre

**Slope:** 35 %                      **Aspect:** North  
**Residual Dry Matter Objective:** 1000-1500  
**RDM Class When Surveyed:** High

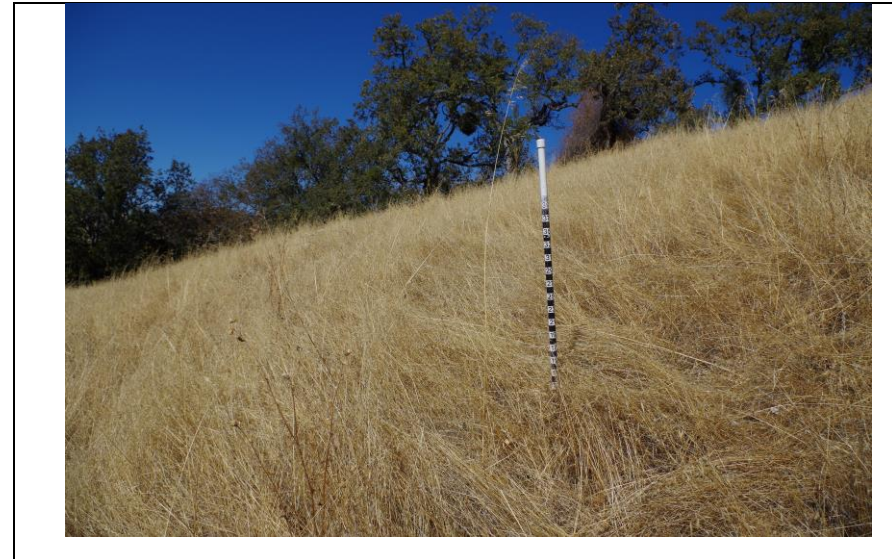
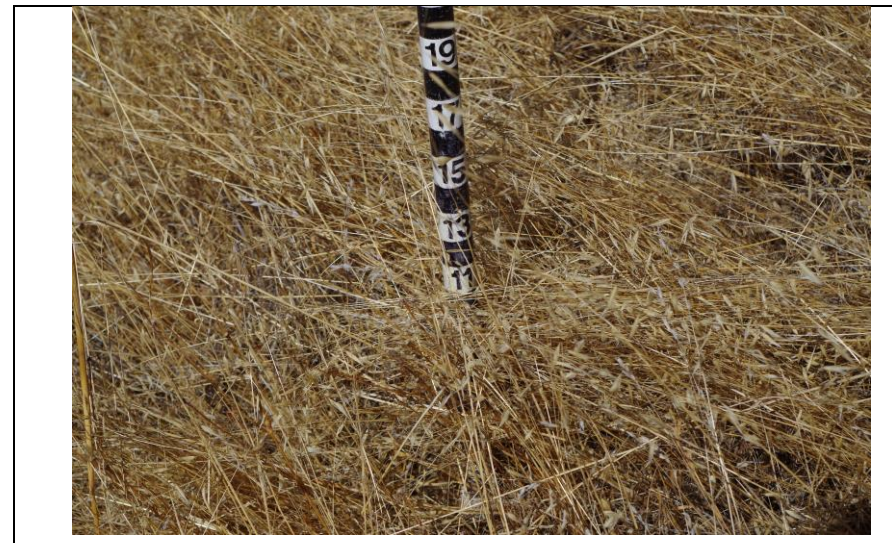
**Monitoring Site #**SW1

Clipped 2,800 lbs/acre RDM

**Slope:** 46 %                      **Aspect:** West  
**Residual Dry Matter Objective:** 1000-1500  
**RDM Class When Surveyed:** High

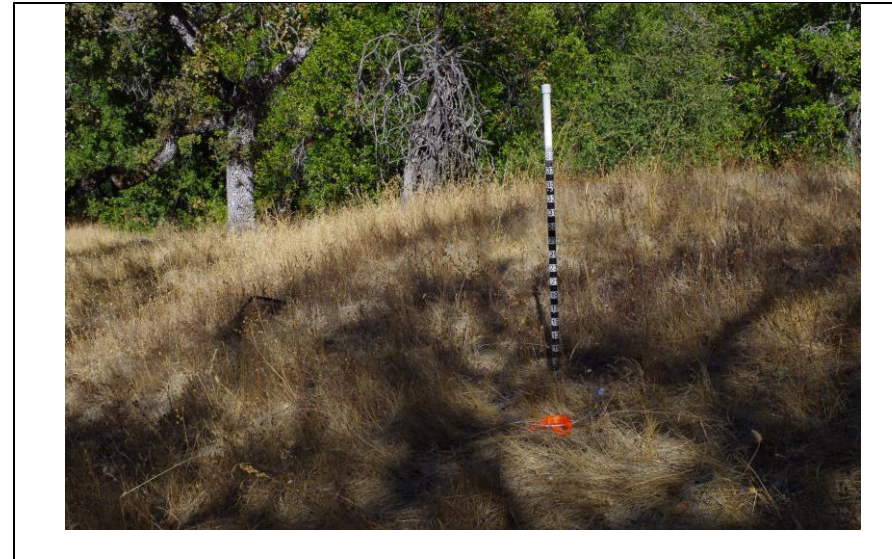
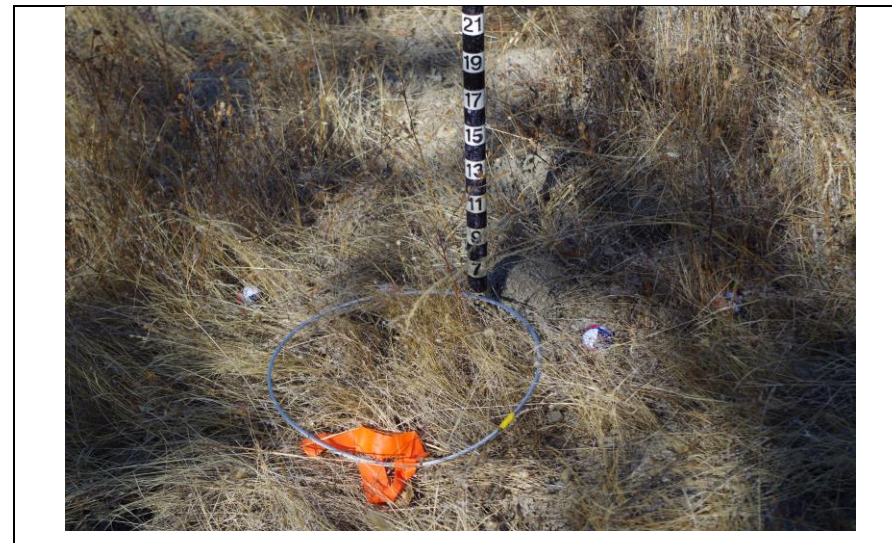
**Monitoring Site #SE1**

Most of area is variable 1,000-2,000 lbs/acre RDM

No apparent livestock use. Rooting by pigs in vicinity. Also pocket gopher activity.

**Slope:** 28 %      **Aspect:** North  
**Residual Dry Matter Objective:** 1000-1500  
**RDM Class When Surveyed:** Meets
