Americans with Disabilities Act (ADA) Self-Evaluation and Transition Plan

Facilities Access Compliance Survey Report for the Santa Clara Valley Open Space Authority

April 2023
SSA Project # 21058

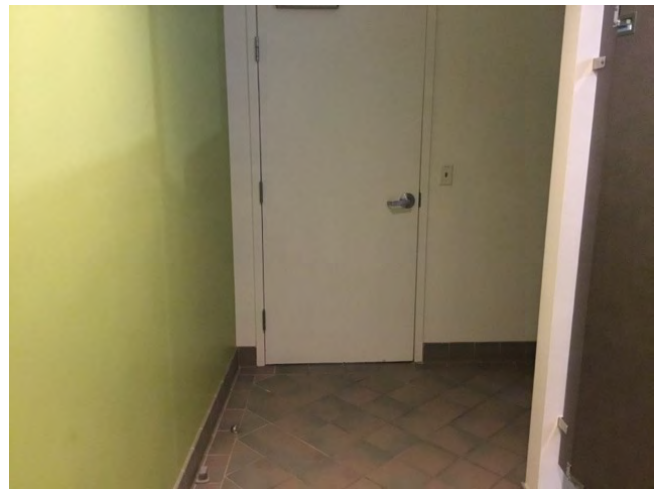
| 2478 | <ul style="list-style-type: none"> As-Built Description: Front approach: At pull side, door does not have clear and level maneuvering space measuring door width plus 18" x 60". (24" x 60" at exterior doors). As-Built: 54" Proposed Solution: Remove standard compartment and completely remodel the accessible compartment. | PCODE ID23B ADAAG 91 Fig. 25(a) ADA 2010 404.2.4 CBC 2007 11B-26A(a) CBC 2019 11B-404.2.4 | 1 | JOB | \$16,800 | \$16,800 |

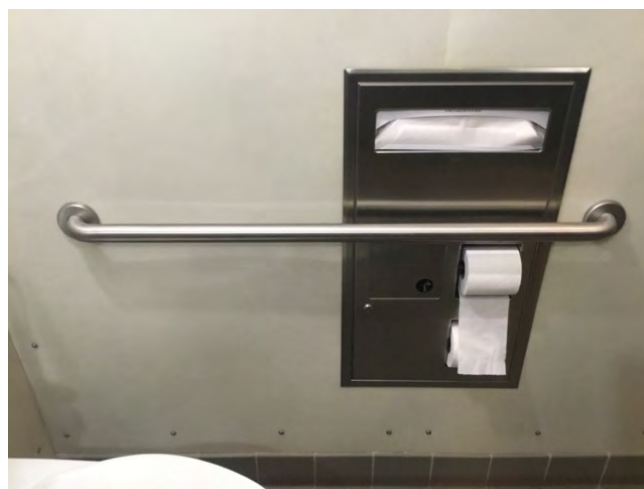
| 2493 | <ul style="list-style-type: none"> As-Built Description: Accessories/dispensers in accessible stall located closer than 1-1/2" below or 12" above grab bar impedes its use. As-Built: 1.125" Proposed Solution: Relocate accessories/dispensers to be no closer than 1-1/2" below and 12" above grab bars (except if accessories are recessed, flush with wall, and have no sharp edges). | PCODE WB07I ADAAG 91 4.26.2 ADA 2010 609.3 CBC 2007 1133B.4.2.5 CBC 2019 11B-609.3 | 1 | JOB | \$225 | \$225 |

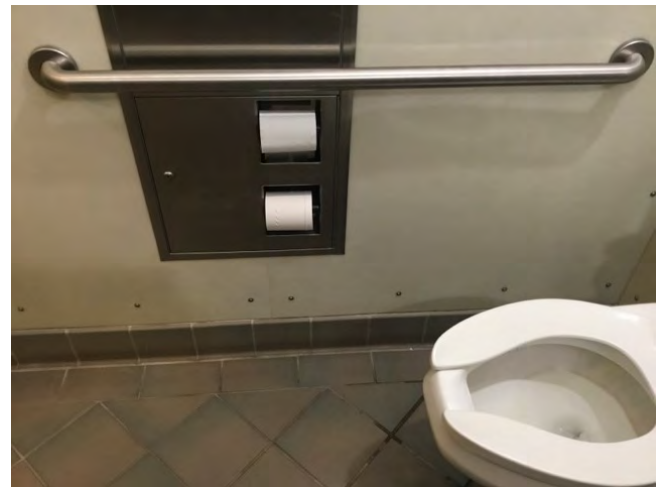
2489

- *As-Built Description:*
Accessories/dispensers in accessible stall located closer than 1-1/2" below or 12" above grab bar impedes its use.
- *As-Built:* **1.25"**
- *Proposed Solution:*
Relocate accessories/dispensers to be no closer than 1-1/2" below and 12" above grab bars (except if accessories are recessed, flush with wall, and have no sharp edges).

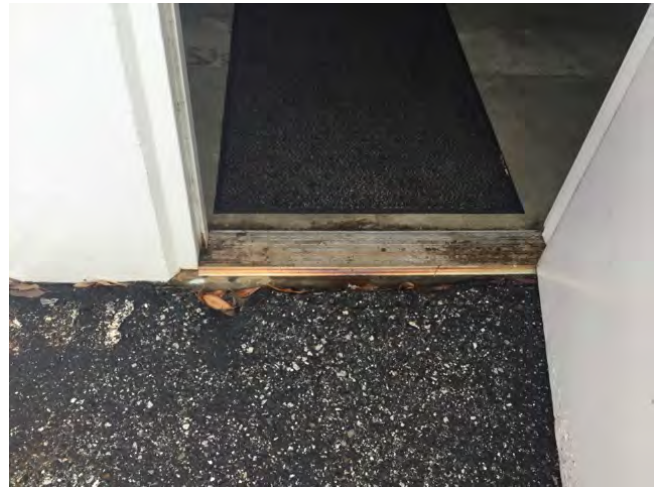
| Item no., Rm no. and Name | Existing Architectural Barrier and Proposed Solution | Codes / Mitigation Info | Qty | Unit | Cost | Total |
|---|---|--|---|---|---|---|
| 2498 | <ul style="list-style-type: none"> As-Built Description: Door inaccessible due to threshold or step at door exceeding 1/2". As-Built: 3" Proposed Solution: Repair the surface. | PCODE ID02A ADAAG 91 4.13.8 ADA 2010 404.2.5 CBC 2007 1133B.2.4.1 CBC 2019 11B-404.2.5 | 1 | JOB | \$1,200 | \$1,200 |

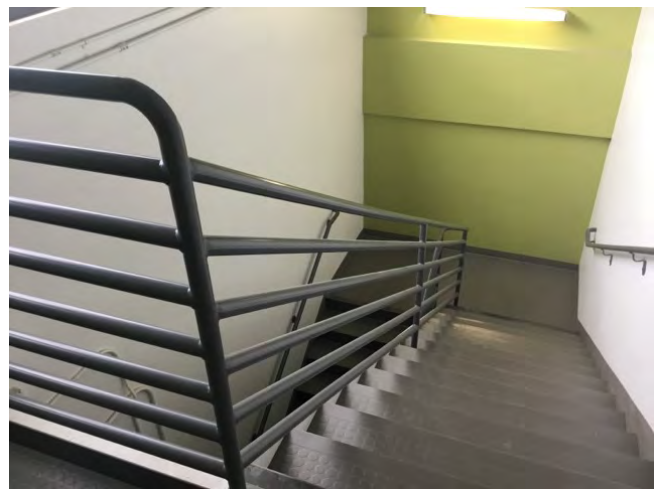
| <i>Item no., Rm no. and Name</i> | <i>Existing Architectural Barrier and Proposed Solution</i> | <i>Codes / Mitigation Info</i> | <i>Qty</i> | <i>Unit</i> | <i>Cost</i> | <i>Total</i> |
|---|---|---|---|---|---|---|
| 2495 | <ul style="list-style-type: none"> <i>As-Built Description:</i> Guards (42" high) not provided at side of ramp or landing where drop-off to adjacent grade or floor exceeds 30" height (California building code requirement only). <i>Proposed Solution:</i> Provide new guards, including handrail at ramp. | <p><i>PCODE ED08</i></p> <p><i>CBC 2007 1133B.5.7</i></p> <p><i>CBC 2019 Section 1013.2; 1013.3</i></p> | 20 | LF | \$360 | \$7,200 |

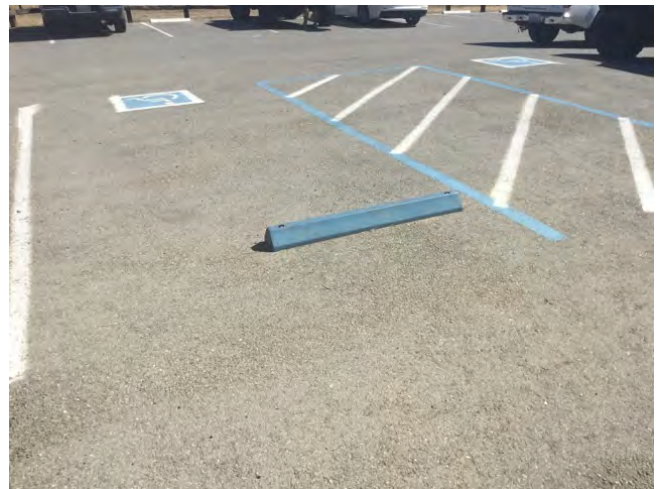
| 2281 | <ul style="list-style-type: none"> As-Built Description: The words "NO PARKING" not painted on the ground within loading and unloading access aisle (12" min high white letters), located so that it is visible to traffic enforcement officials (required in CA only). Proposed Solution: Provide the words "NO PARKING" in each access aisle, painted in 12" high letters, when altering area. | PCODE EA04D CBC 2007 1129B.3.1 CBC 2019 11B-502.3.3 | 1 | JOB | \$300 | \$300 |

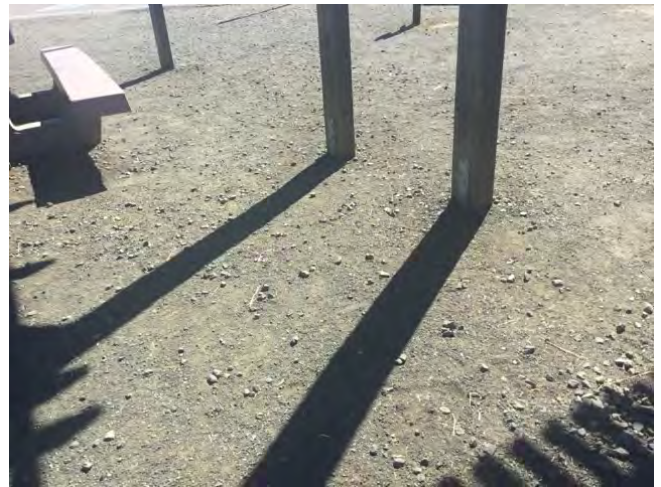
| Item no., Rm no. and Name | Existing Architectural Barrier and Proposed Solution | Codes / Mitigation Info | Qty | Unit | Cost | Total |
|---|---|--|---|---|---|--|
| 2292 | <ul style="list-style-type: none"> As-Built Description: Walk: Pavement dislocation creates abrupt change in level exceeding 1/2" in accessible route. As-Built: To 1" caused by large aggregate. Proposed Solution: Install smaller aggregate. | PCODE EF03 ADAAG 91 4.3.8 ADA 2010 403.4 CBC 2007 1133B.7.4 CBC 2019 11B-403.4 | 1 | JOB | \$6,000 | \$6,000 |

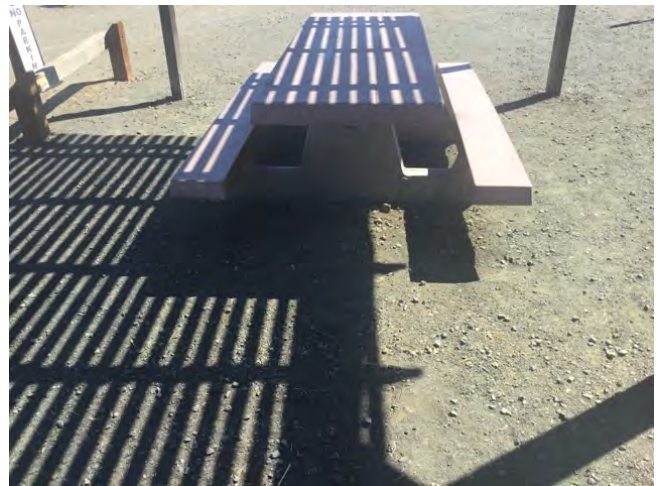
| 2293 | <ul style="list-style-type: none"> As-Built Description: Clear space has slopes greater than 1:48. As-Built: To 10% caused by uneven surface Proposed Solution: Grade surface. | PCODE NI07 ADAAG 91 16.6.6 ADA 2010 305.2 CBC 2007 1132B.1 CBC 2019 11B-305.2 | 1 | JOB | | |

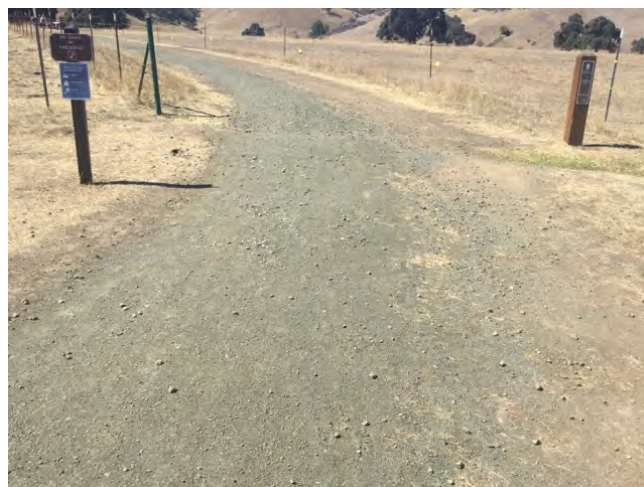
| Item no., Rm no. and Name | Existing Architectural Barrier and Proposed Solution | Codes / Mitigation Info | Qty | Unit | Cost | Total |
|---|--|---|---|---|---|--|
| 2302 | <ul style="list-style-type: none"> As-Built Description: Walk: Pavement dislocation creates abrupt change in level exceeding 1/2" in accessible route. As-Built: To 1" caused by aggregate. Proposed Solution: Install smaller aggregate. Notes: A section approximately 500 feet from the trailhead has 3" aggregate. | PCODE EF03REF ADAAG 91 4.3.8 ADA 2010 403.4 CBC 2007 1133B.7.4 CBC 2019 11B-403.4 | | REF | | |

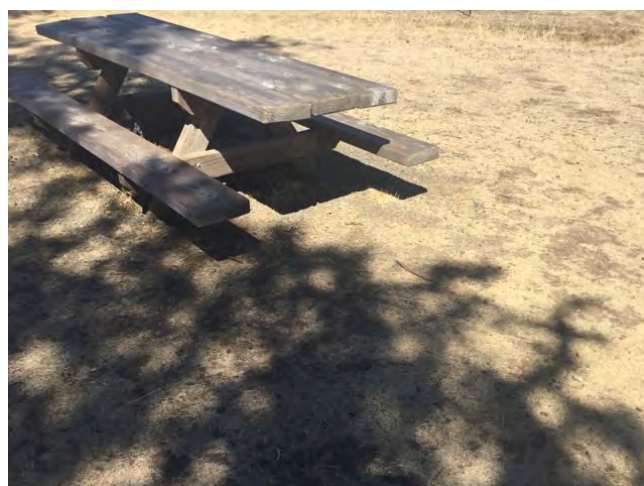
| 2300 | <ul style="list-style-type: none"> As-Built Description: Clear space has slopes greater than 1:48. As-Built: To 9% at picnic tables. Proposed Solution: Grade surface. | PCODE NI07 ADAAG 91 16.6.6 ADA 2010 305.2 CBC 2007 1132B.1 CBC 2019 11B-305.2 | 1 | JOB | \$1,200 | \$1,200 |

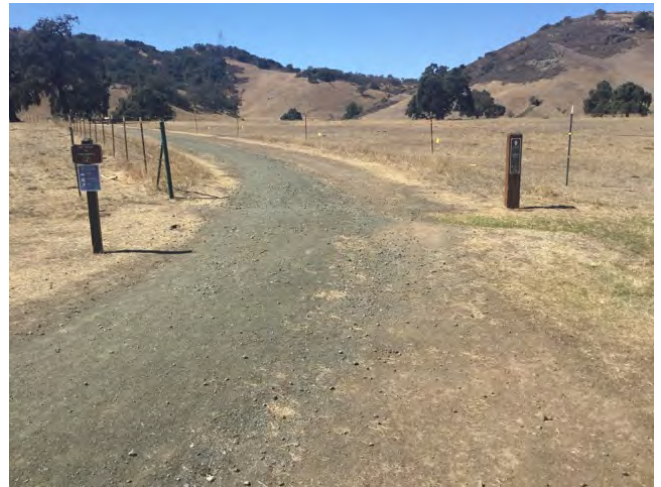
| Item no., Rm no. and Name | Existing Architectural Barrier and Proposed Solution | Codes / Mitigation Info | Qty | Unit | Cost | Total |
|---|--|--|---|---|---|--|
| 2303 | <ul style="list-style-type: none"> As-Built Description: Cross slope more than 1":48" (2.083%). As-Built: Varies. 6.4% cross slopes. 11% slopes. Proposed Solution: Modify slope and cross slope. Notes: Occurs sporadically throughout the level portion of the trail. Consider whether the widened and graded portions of the trail are "improved ". See 11B-246.7 | PCODE EF07 ADAAG 91 4.3.7 ADA 2010 403.3 CBC 2007 1133B.7.1.3 CBC 2019 11B-403.3 | 1000 | SF | \$21 | \$210,000 |

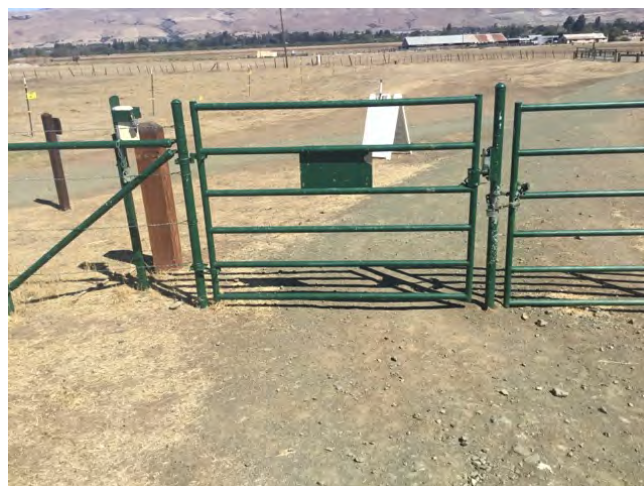
| 2308 | <ul style="list-style-type: none"> <i>As-Built Description:</i> Surface of required maneuvering clearance at door slopes more than 1/4":12" (2.0%). <i>As-Built:</i> 11% <i>Proposed Solution:</i> Modify surface slope at door. | PCODE ID11REF ADAAG 91 4.13.6 ADA 2010 404.2.4.4 CBC 2007 1133B.2.4 CBC 2019 11B-404.2.4 | | REF | | |

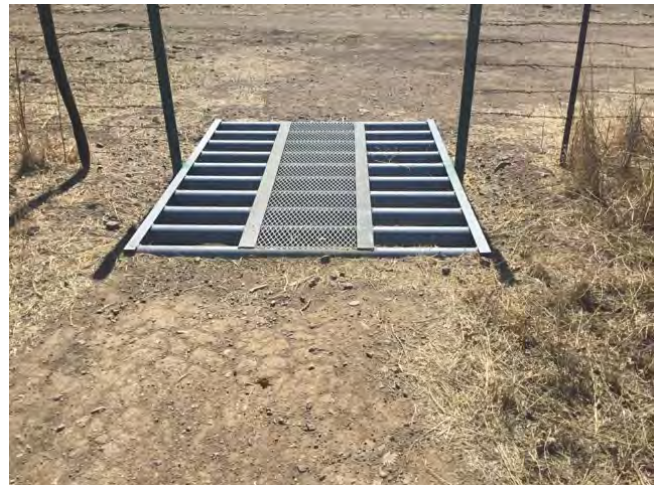
| Item no., Rm no. and Name | Existing Architectural Barrier and Proposed Solution | Codes / Mitigation Info | Qty | Unit | Cost | Total |
|---|--|--|---|---|---|---|
| 2306 | <ul style="list-style-type: none"> As-Built Description: Walk: Grating has grid openings greater than 1/2" along the line of traffic flow. As-Built: 5" Proposed Solution: Replace grates. Install gates at cattle guards. | PCODE EF04 ADAAG 91 4.3.6; 4.5.4 ADA 2010 403.2; 302.3 CBC 2007 1133B.7.2 CBC 2019 11B-403.2; 11B-302.3 | 2 | JOB | \$4,500 | \$9,000 |

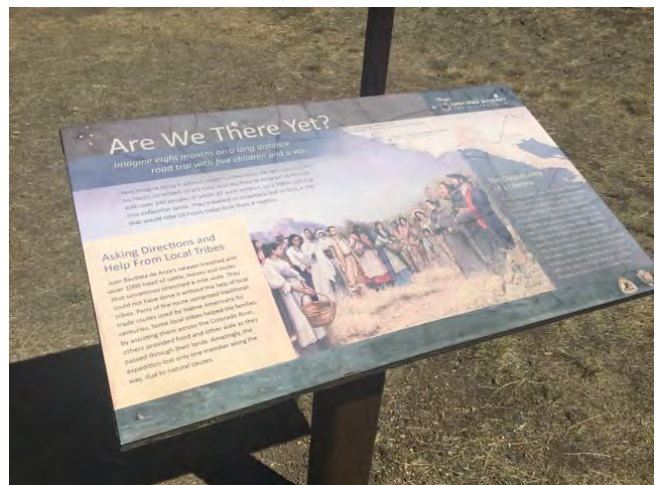
| 2298 | <ul style="list-style-type: none"> As-Built Description: Sign characters not readable because they are not sized for viewing distance. Proposed Solution: Provide compliant signage. | PCODE SA02A ADAAG 91 4.30.3 ADA 2010 703.5.5 CBC 2007 1117B.5.4 CBC 2019 11B-403.3 | 1 | JOB | \$3,000 | \$3,000 |

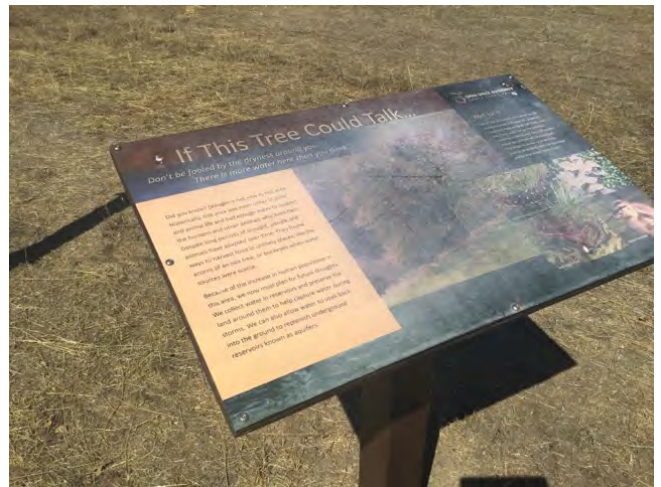
| 2301 | <ul style="list-style-type: none"> As-Built Description: Sign characters not readable because they are not sized for viewing distance. .25" characters Proposed Solution: Provide compliant signage. | PCODE SA02A ADAAG 91 4.30.3 ADA 2010 703.5.5 CBC 2007 1117B.5.4 CBC 2019 11B-305.2 | 1 | JOB | \$3,000 | \$3,000 |

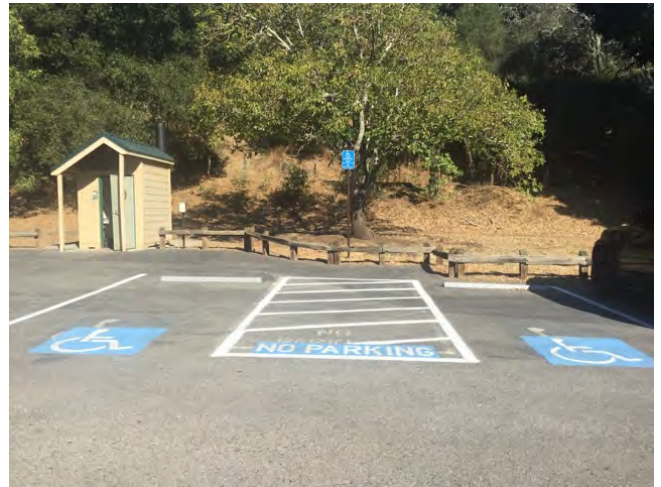
| Item no., Rm no. and Name | Existing Architectural Barrier and Proposed Solution | Codes / Mitigation Info | Qty | Unit | Cost | Total |
|---|---|---|---|---|---|---|
| 2312 | <ul style="list-style-type: none"> • <i>As-Built Description:</i> Sign for accessible parking space is missing or non-compliant. • <i>Proposed Solution:</i> Provide compliant parking signage. • Notes: Signs should be placed at the head of each space. | PCODE EA04B ADAAG 91 4.6.4 ADA 2010 502.6 CBC 2007 1129B.4 CBC 2019 11B-502.6 | 2 | JOB | \$945 | \$1,890 |

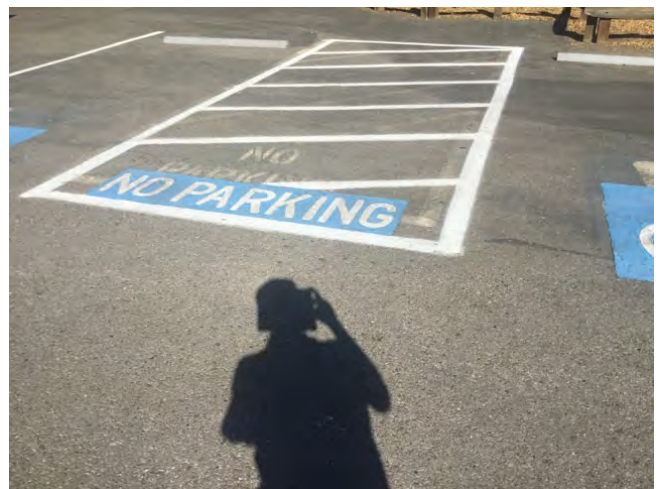
| 2314 | <ul style="list-style-type: none"> As-Built Description: An accessible parking space shall be outlined or painted blue (required in CA only). Proposed Solution: Identify accessible parking space using blue markings. | PCODE EA04K CBC 2019 11B-502.6 | 1 | JOB | \$360 | \$360 |

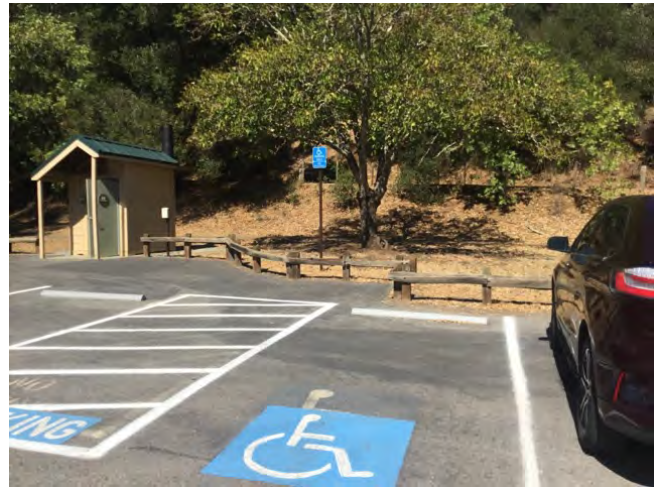
| Item no., Rm no. and Name | Existing Architectural Barrier and Proposed Solution | Codes / Mitigation Info | Qty | Unit | Cost | Total |
|---|---|--|---|---|---|---|
| 2345 | <ul style="list-style-type: none"> • <i>As-Built Description:</i> No "Tow Away" sign at parking lot entrance (required in CA only). • <i>Proposed Solution:</i> Provide "Tow Away" sign at parking lot entrance when altering area. | <p>PCODE EA04C</p> <p>CBC 2007 1129B.4</p> <p>CBC 2019 11B-502.8.2</p> | 1 | JOB | \$975 | \$975 |

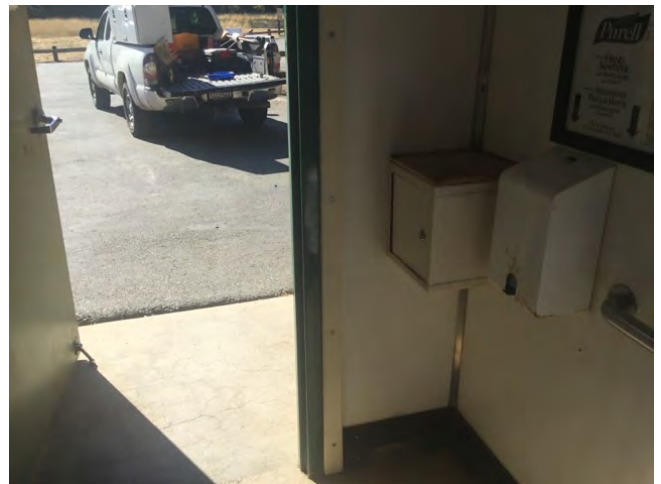
• *As-Built Description:*
 Front approach: At push side, door does not have clear and level maneuvering space measuring door width x 48" (door width plus 12" if door has both, latch and closer).

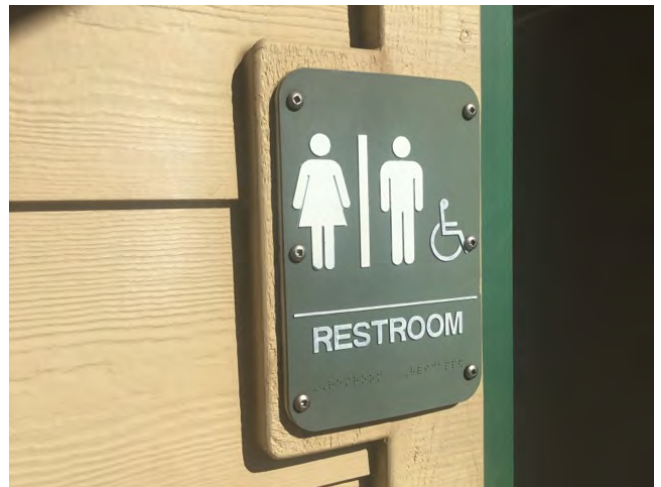
| Item no., Rm no. and Name | Existing Architectural Barrier and Proposed Solution | Codes / Mitigation Info | Qty | Unit | Cost | Total |
|---|--|---|---|---|---|--|
| 2319 | <ul style="list-style-type: none"> As-Built Description: Sign characters are not sans serif, upper case, and/or raised 1/32" min. As-Built: Spaces between tactile characters <1/16". Braille 3/4" from tactile characters. Proposed Solution: Provide compliant signage. | PCODE SA04 ADAAG 91 4.30.4 ADA 2010 703.2 CBC 2007 1117B.5.5 CBC 2019 11B-216.6 | 1 | JOB | \$270 | \$270 |

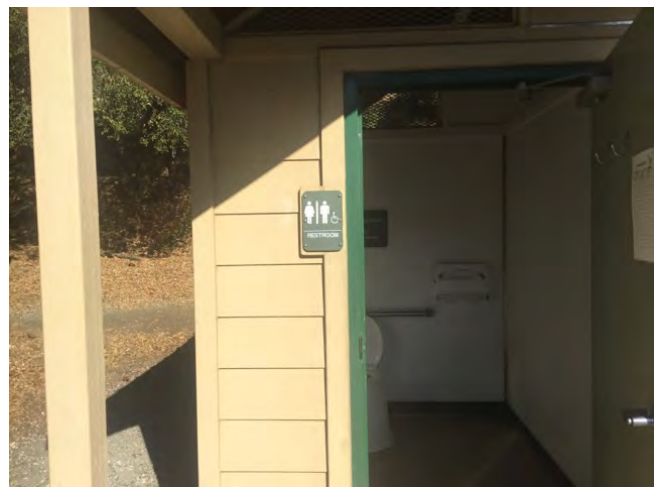
| 2318 | <ul style="list-style-type: none"> As-Built Description: Signs containing tactile characters is not located so that a clear floor space of 18" min x 18" min., centered on the tactile characters, is provided beyond the arc of any door swing between the closed position and 45 degree open position. As-Built: 5.5" from door swing. Proposed Solution: Relocate compliant signage on latch side of door located at compliant height with a clear floor space. | PCODE SA07B ADA 2010 703.4.2 CBC 2019 11B-703.4.2 | 1 | JOB | \$150 | \$150 |

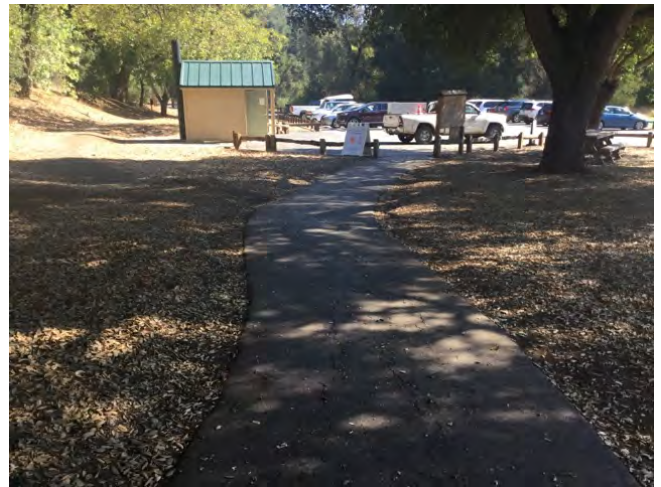
Detectable Warning

| 2327 | <ul style="list-style-type: none"> As-Built Description: 36" wide band of truncated domes not provided at walkway or crossing adjoining a vehicular way, if surfaces are not separated by a curb, railing, or other element. Proposed Solution: Provide 36" wide, contrasting color, band of truncated domes between pedestrian and vehicular area. | PCODE EG09 ADAAG 91 4.29.5 CBC 2007 1133B.8.5 CBC 2019 11B-705.1.2.5 | 10 | LF | \$81 | \$810 |

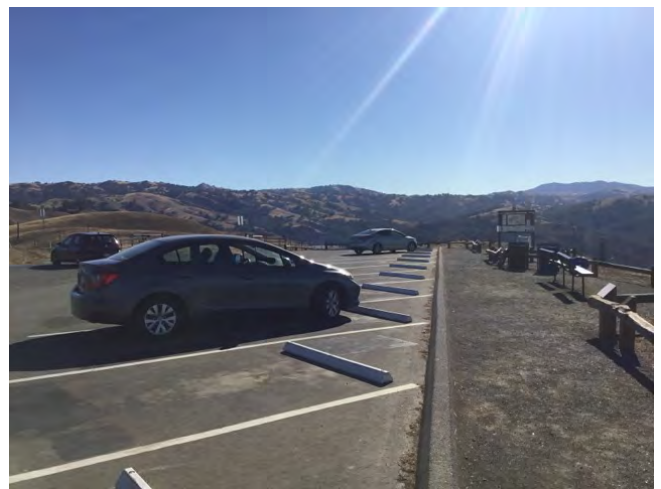
| Item no., Rm no. and Name | Existing Architectural Barrier and Proposed Solution | Codes / Mitigation Info | Qty | Unit | Cost | Total |
|---|---|--|---|---|---|--|
| 2268 | <ul style="list-style-type: none"> As-Built Description: Sign characters not readable because they are not sized for viewing distance. As-Built: 1/8"-3/8" characters on informational signs. Proposed Solution: Provide compliant signage. Notes: Includes warning signs and other information re history etc. | PCODE SA02A ADAAG 91 4.30.3 ADA 2010 703.5.5 CBC 2007 1117B.5.4 CBC 2019 11B-402.2 | 1 | JOB | \$6,000 | \$6,000 |

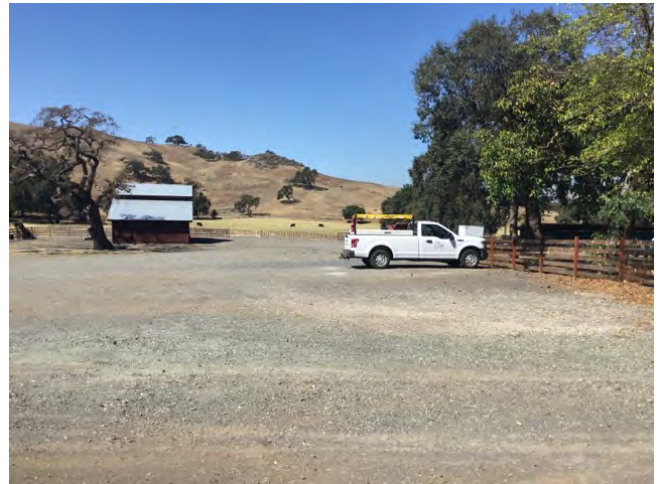
- *As-Built Description:*
36" wide band of truncated domes not provided at walkway or crossing adjoining a vehicular way, if surfaces are not separated by a curb, railing, or other element.
- *Proposed Solution:*
Provide 36" wide, contrasting color, band of truncated domes between pedestrian and vehicular area.
- **Notes:**
This condition occurs throughout the site. Coordinate with parking and circulation path design.

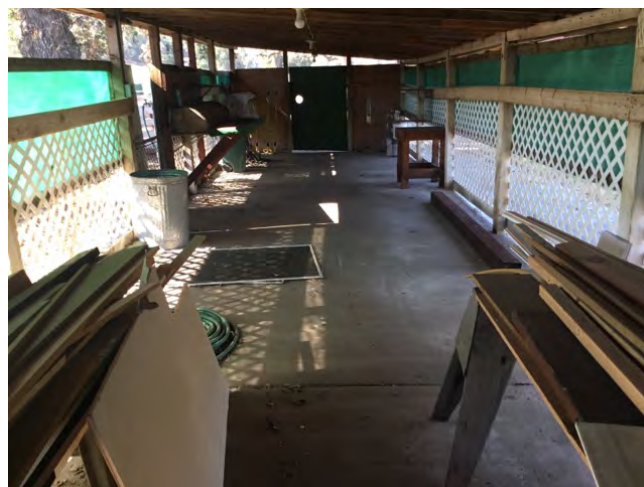
Door

| 2356 | <ul style="list-style-type: none"> As-Built Description: At push side of door on accessible route, bottom 10" does not have a smooth, uninterrupted surface. Proposed Solution: Provide 10" min. "kick plate" covering width of door when altering area. Notes: This element complies with Safe Harbor if altered or constructed before March 15, 2012. See exceptions for animal containment areas. However accessibility should be provided if the public is provided access. | PCODE ID06 ADA 2010 404.2.10 CBC 2007 1133B.2.6 CBC 2019 11B-404.2.10 | 1 | JOB | \$300 | \$300 |

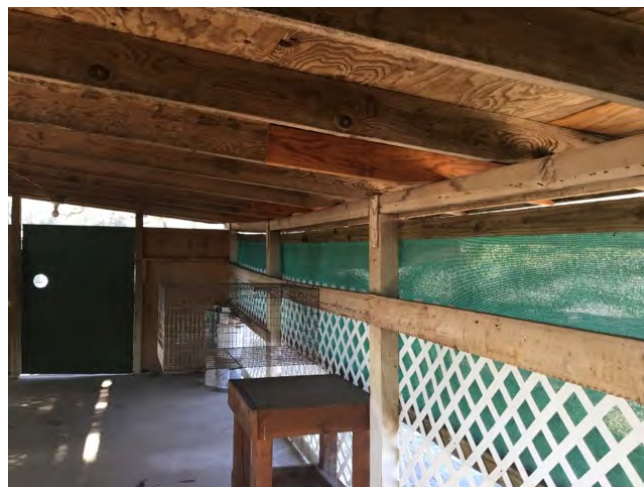
| 2353 | <ul style="list-style-type: none"> As-Built Description: Overhead clearance less than 80" above finished floor. As-Built: 72" Proposed Solution: Alter ceiling. Notes: See exceptions for animal containment areas. Consider modifications for safety . | PCODE EG01AREF ADAAG 91 4.4.2 ADA 2010 307.4 CBC 2007 1133B.8.6.2 CBC 2019 11B-307.4 | | REF | | |

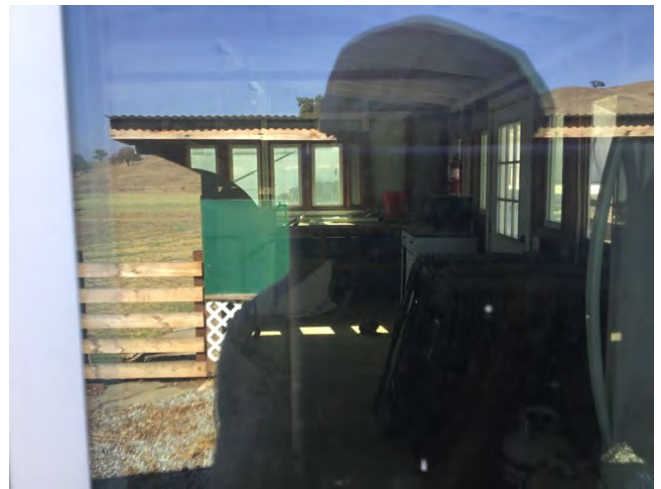
| 2367 | <ul style="list-style-type: none"> As-Built Description: Sink does not have knee space min. 27" high x 19" deep x 30" wide. Proposed Solution: Remodel sink cabinet. | PCODE IN06A ADAAG 91 4.24.3 ADA 2010 606.2 CBC 2007 1115B.4.7.1 CBC 2019 11B-606.2 | 1 | JOB | \$5,250 | \$5,250 |

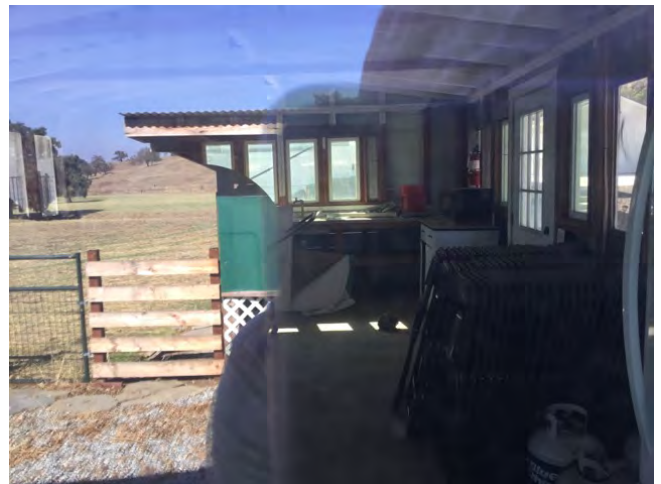
| Item no., Rm no. and Name | Existing Architectural Barrier and Proposed Solution | Codes / Mitigation Info | Qty | Unit | Cost | Total |
|---|--|---|---|---|---|---|
| 2361 | <ul style="list-style-type: none"> As-Built Description: Walk more than 36" but less than 48" wide (required in CA only). As-Built: 46" Proposed Solution: Enlarge width of walk to 48". | <p>PCODE EF08</p> <p>CBC 2007 1133B.7.1</p> <p>CBC 2019 11B-403.5.1.3</p> | 20 | SF | \$135 | \$2,700 |

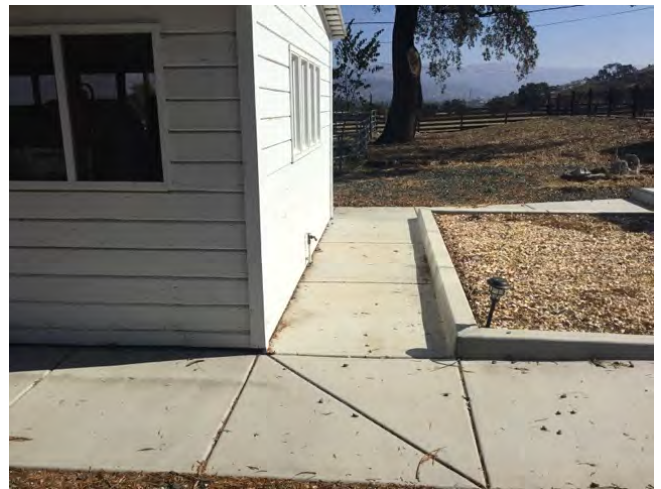
| 2362 | <ul style="list-style-type: none"> As-Built Description: Walk more than 36" but less than 48" wide (required in CA only). As-Built: 39" to pipe 46" to wall. Proposed Solution: Enlarge width of walk to 48". | <p>PCODE EF08</p> <p>CBC 2007 1133B.7.1</p> <p>CBC 2019 11B-403.5.1.3</p> | 20 | SF | \$135 | \$2,700 |

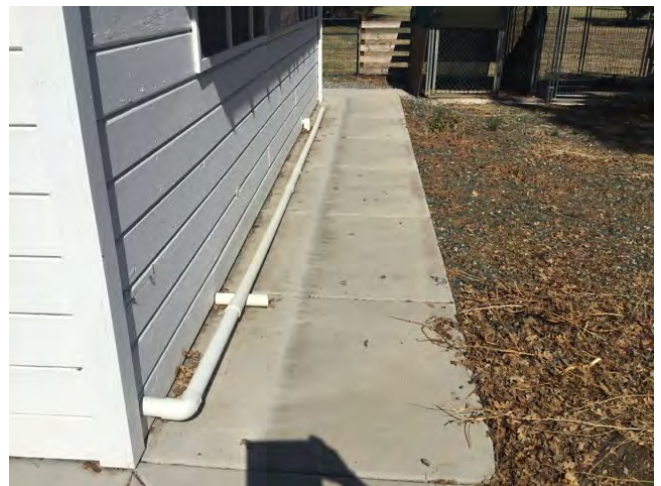
| Item no., Rm no. and Name | Existing Architectural Barrier and Proposed Solution | Codes / Mitigation Info | Qty | Unit | Cost | Total |
|---|--|--|---|---|---|--|
| 2359 | <ul style="list-style-type: none"> As-Built Description: Walk more than 36" but less than 48" wide (required in CA only). As-Built: 47" Proposed Solution: Enlarge width of walk to 48". | <p>PCODE EF08REF</p> <p>ADA 2010 403.5</p> <p>CBC 2007 1133B.7.1</p> <p>CBC 2019 11B-403.5.1.3</p> | | REF | | |

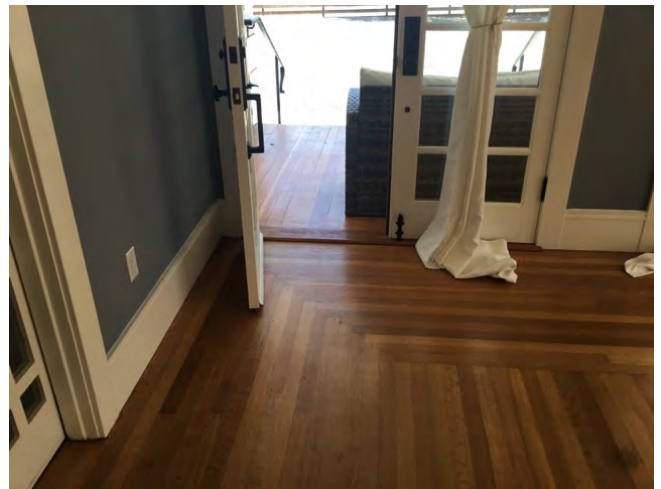
| 2411 | <ul style="list-style-type: none"> As-Built Description: Door inaccessible due to threshold or step at door exceeding 1/2". As-Built: 2.5" Proposed Solution: Modify threshold when providing access with ramps or other accessible routes. | PCODE ID02A ADAAG 91 4.13.8 ADA 2010 404.2.5 CBC 2007 1133B.2.4.1 CBC 2019 11B-404.2.5 | 2 | JOB | \$1,200 | \$2,400 |

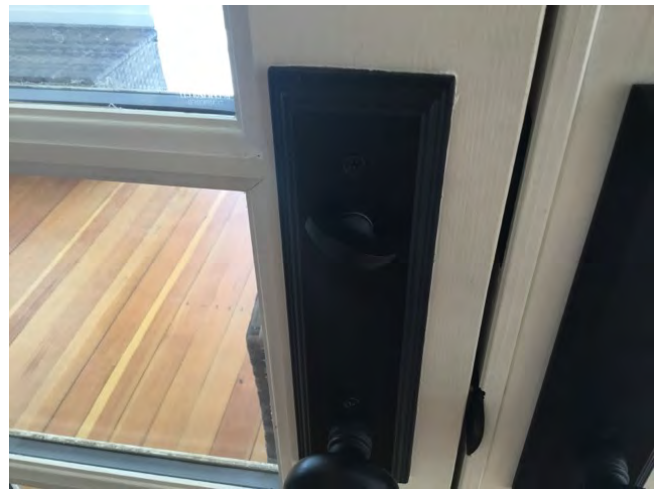
| 2408 | <ul style="list-style-type: none"> As-Built Description: Operable part(s) require tight grasping, pinching, or twisting of the wrist with one hand. As-Built: Not operable without grasping. Proposed Solution: Modify or replace the operable part(s) to not require tight grasping, pinching, or twisting of the wrist with one hand. | PCODE IC02 ADAAG 91 4.27.4 ADA 2010 309.4 CBC 2007 1117B.6.4 CBC 2019 11B-309.4 | 1 | JOB | \$900 | \$900 |

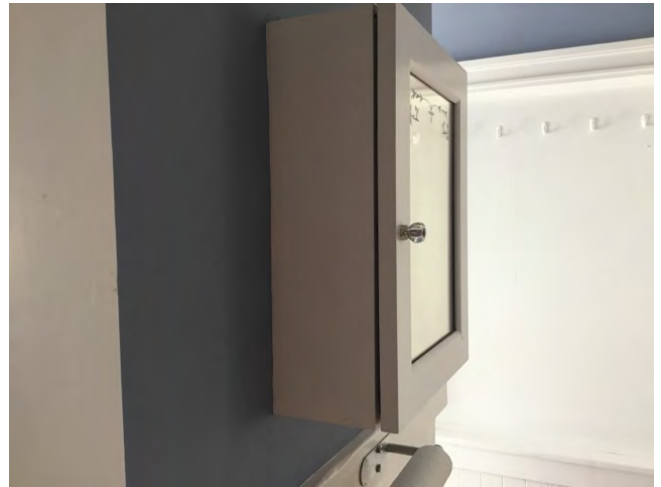
| 2412 | <ul style="list-style-type: none"> As-Built Description: Protruding objects more than 4" from wall, when bottom of object more than 27" or less than 80" above finished floor. As-Built: 5" at 75". 6" at 78". Proposed Solution: Remove/relocate protruding object. Patch existing surface. | PCODE EG04 ADAAG 91 4.4.1 ADA 2010 307.2 CBC 2007 1133B.8.6.1 CBC 2019 11B-307.2 | 2 | JOB | \$300 | \$600 |

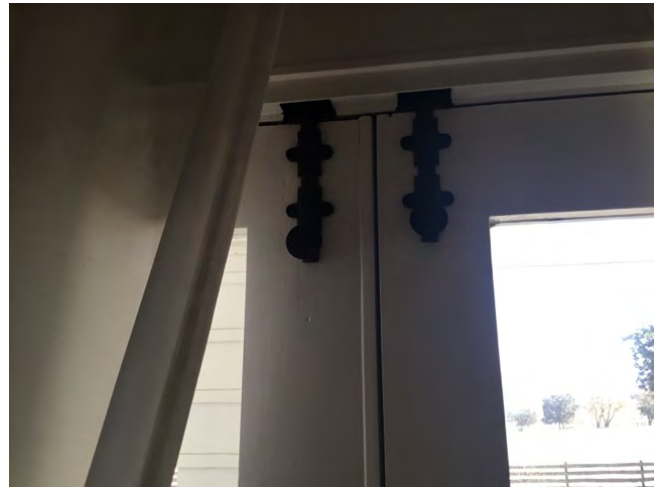
| 2381 | <ul style="list-style-type: none"> As-Built Description: Reach height to control or access point, where side approach is available, exceeds 48" or is less than 15" in height, or exceeds 10" in depth. As-Built: Side reach obstructed by 37" high counter. Proposed Solution: Lower counters. Provide 24" maximum reach to electrical outlets. | PCODE IE02 ADAAG 91 4.2.6 ADA 2010 308.3.1 CBC 2007 1118B.6 CBC 2019 11B-308.3 | 1 | JOB | \$60,000 | \$60,000 |

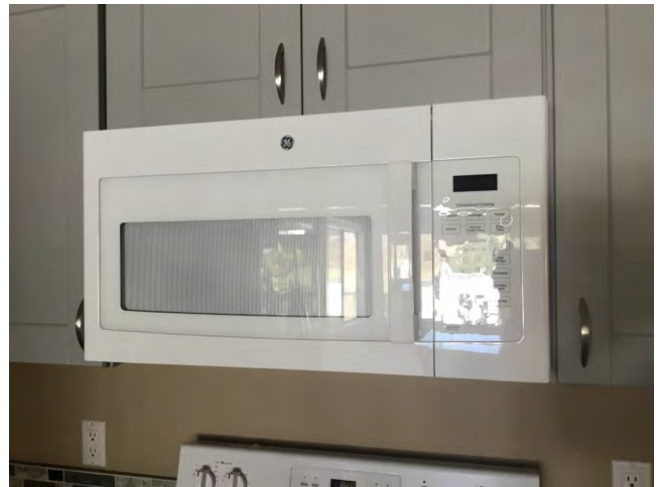
| 2392 | <ul style="list-style-type: none"> As-Built Description: Reach height to control or access point, where side approach is available, exceeds 48" or is less than 15" in height, or exceeds 10" in depth. As-Built: 63" Proposed Solution: Modify equipment or mounting. | PCODE IE02 ADAAG 91 4.2.6 ADA 2010 308.3.1 CBC 2007 1118B.6 CBC 2019 11B-308.3 | 1 | JOB | \$300 | \$300 |

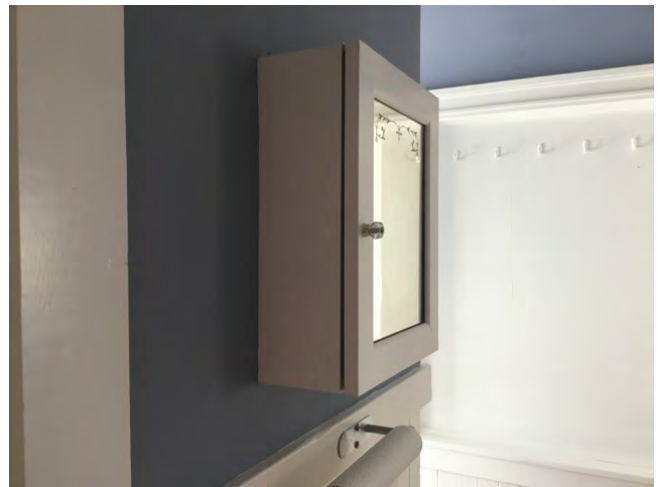
| Item no., Rm no. and Name | Existing Architectural Barrier and Proposed Solution | Codes / Mitigation Info | Qty | Unit | Cost | Total |
|---|--|---|---|---|---|---|
| 2394 | <ul style="list-style-type: none"> As-Built Description: Reach height to control or access point, where side approach is available, exceeds 48" or is less than 15" in height, or exceeds 10" in depth. As-Built: 75" Proposed Solution: Modify equipment or mounting. | PCODE IE02 ADAAG 91 4.2.6 ADA 2010 308.3.1 CBC 2007 1118B.6 CBC 2019 11B-308.3 | 1 | JOB | \$300 | \$300 |

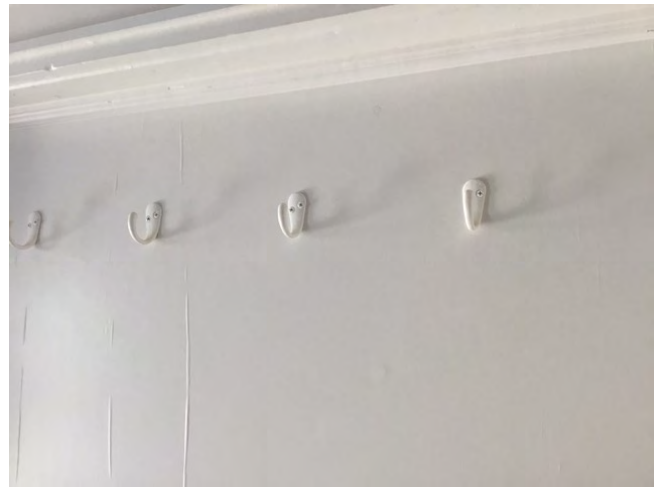
| 2400 | <ul style="list-style-type: none"> As-Built Description: Reach height to control or access point, where side approach is available, exceeds 48" or is less than 15" in height, or exceeds 10" in depth. As-Built: 24" deep 52" AFF. Proposed Solution: Modify equipment or mounting. | PCODE IE02 ADAAG 91 4.2.6 ADA 2010 308.3.1 CBC 2007 1118B.6 CBC 2019 11B-308.3 | 1 | JOB | \$300 | \$300 |

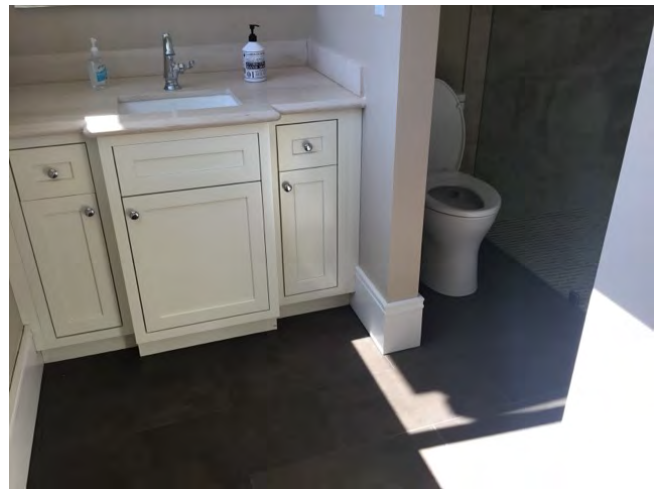
| 2380 | <ul style="list-style-type: none"> • <i>As-Built Description:</i> Single accommodation restroom not accessible; multiple compliance violations. • <i>As-Built:</i> 32" x 71" • <i>Proposed Solution:</i> Provide directional signage to accessible restroom. Or Remodel area to provide single-occupant accessible restroom. | PCODE WA01REF ADAAG 91 4.22 ADA 2010 603.1 CBC 2007 1115B.3.2 CBC 2019 11B-603.1 | | REF | | |

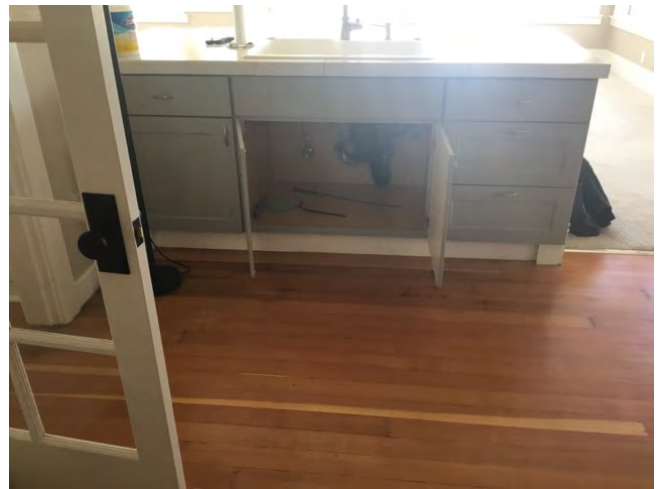
| 2398 | <ul style="list-style-type: none"> • <i>As-Built Description:</i> Sink does not have knee space min. 27" high x 19" deep x 30" wide. • <i>Proposed Solution:</i> Remodel sink cabinet. | PCODE IN06A ADAAG 91 4.24.3 ADA 2010 606.2 CBC 2007 1115B.4.7.1 CBC 2019 11B-606.2 | 1 | JOB | \$5,250 | \$5,250 |

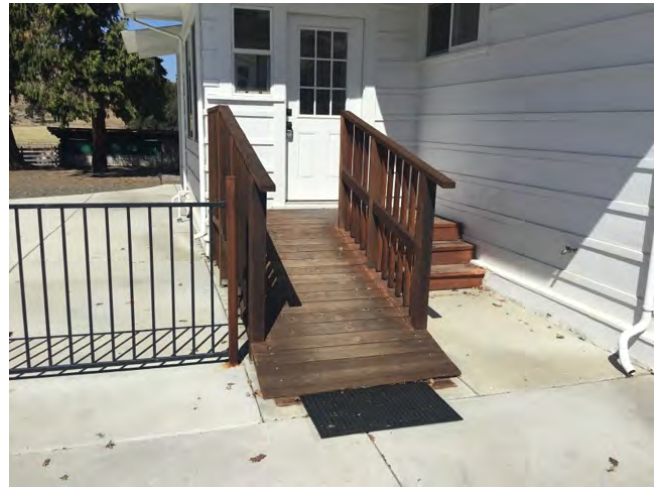
| Item no., Rm no. and Name | Existing Architectural Barrier and Proposed Solution | Codes / Mitigation Info | Qty | Unit | Cost | Total |
|---|---|--|---|---|---|---|
| 2410 | <p>Slope</p> <ul style="list-style-type: none"> As-Built Description: Slope greater than 1:12 (8.3%). As-Built: 22% Proposed Solution: Demolish existing and provide new ramp with handrails. Notes: Multiple barriers at the main entrance ramp and stairs. | <p>PCODE EB02</p> <p>ADAAG 91 4.8.2</p> <p>ADA 2010 405.2</p> <p>CBC 2007 1133B.5.3</p> <p>CBC 2019 11B-405.2</p> | 100 | SF | \$300 | \$30,000 |

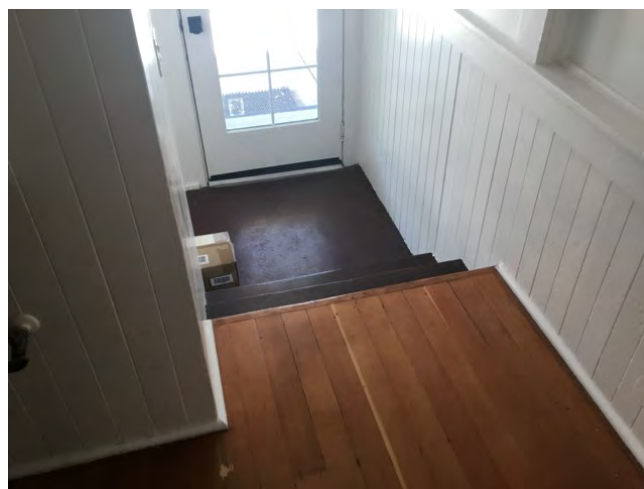
| 2403 | <ul style="list-style-type: none"> <i>As-Built Description:</i> The leading 2" of the tread does not have visual contrast of dark-on-light or light-on-dark from the remainder of the tread. <i>Proposed Solution:</i> Provide 2" min., 4" max. wide contrasting color strip 1" max. from nosing on top & bottom treads when altering area. | PCODE II02B ADA 2010 504.4 CBC 2007 1133B.4.4 CBC 2019 11B-504.4.1 | 16 | LF | \$42 | \$672 |

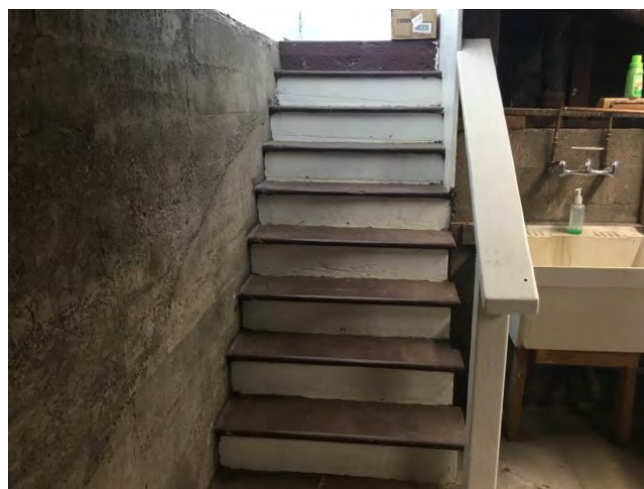
| 2406 | <ul style="list-style-type: none"> As-Built Description: Exterior stair substantially out of compliance. Proposed Solution: Provide complete new stair, 4 ft. wide with landing and handrails. Notes: The surveyor did not find any compliant stairs on the exterior or interior of the building. There are no compliant accessible routes between the levels. | PCODE EC09 ADAAG 91 4.9 ADA 2010 504 CBC 2007 1133B.4 CBC 2019 11B-504 | 400 | IN | \$270 | \$108,000 |

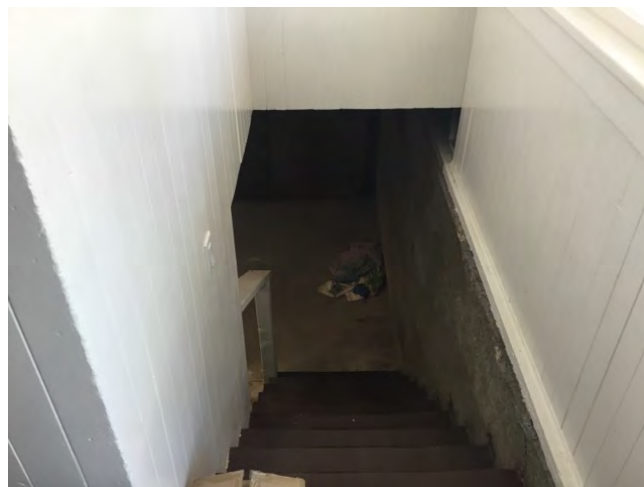
| 2396 | <ul style="list-style-type: none"> As-Built Description: Overhead clearance less than 80" above finished floor. As-Built: 68.5" Proposed Solution: Alter headroom. Notes: Consider technical feasibility. Consider equivalent facilitation. Occurs at stairs to basement. | PCODE EG01A ADAAG 91 4.4.2 ADA 2010 307.4 CBC 2007 1133B.8.6.2 CBC 2019 11B-307.4 | 8 | LF | \$300 | \$2,400 |

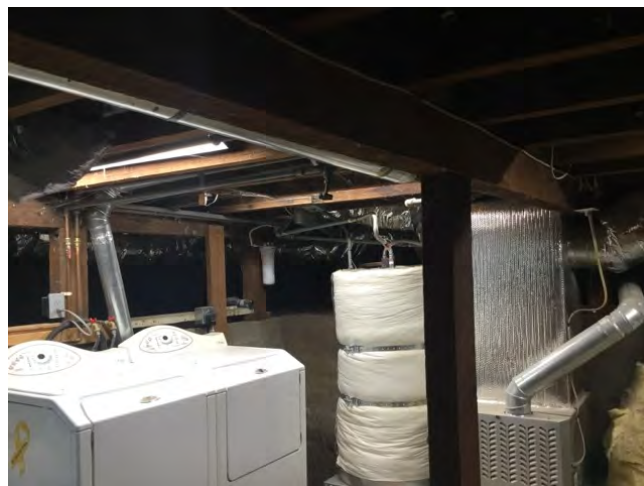
| 2399 | <ul style="list-style-type: none"> As-Built Description: Overhead clearance less than 80" above finished floor. As-Built: 73" Proposed Solution: Dig out the basement. Notes: Consider technical feasibility. | PCODE EG01A ADAAG 91 4.4.2 ADA 2010 307.4 CBC 2007 1133B.8.6.2 CBC 2019 11B-307.4 | 1 | JOB | ? | \$120,000 |

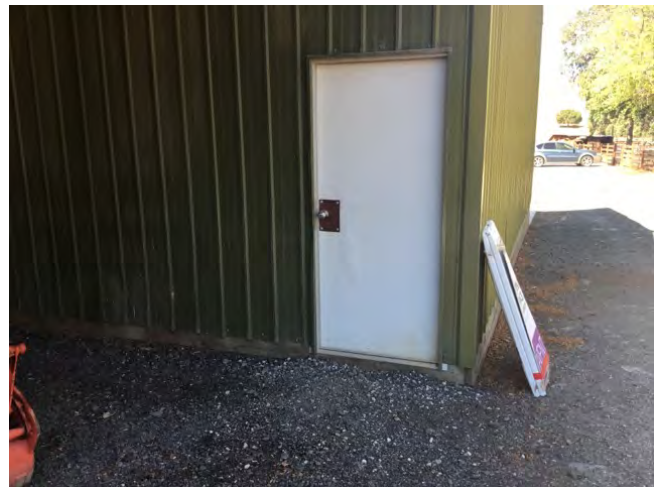
| 2418 | <ul style="list-style-type: none"> • <i>As-Built Description:</i> At time of survey, room was locked and could not be accessed. • <i>Proposed Solution:</i> Verify elements in room are compliant with ADA. | <p>PCODE XA03</p> <p>CBC 2019 11B-403.5.1.3</p> | | REF | | |

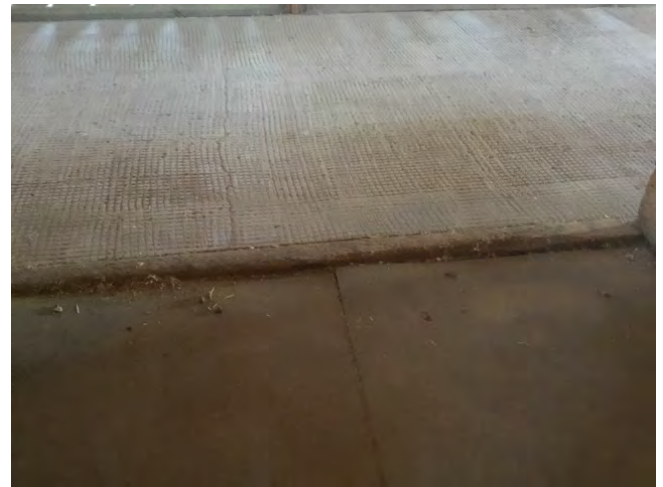
| Item no., Rm no. and Name | Existing Architectural Barrier and Proposed Solution | Codes / Mitigation Info | Qty | Unit | Cost | Total |
|---|---|--|---|---|---|---|
| 2428 | <ul style="list-style-type: none"> As-Built Description: Walk: Pavement dislocation creates abrupt change in level exceeding 1/2" in accessible route. As-Built: 2" Proposed Solution: Remove, replace or repair area of pavement sufficient to correct abrupt change in level. | PCODE EF03 ADAAG 91 4.3.8 ADA 2010 403.4 CBC 2007 1133B.7.4 CBC 2019 11B-403.4 | 40 | SF | \$63 | \$2,520 |

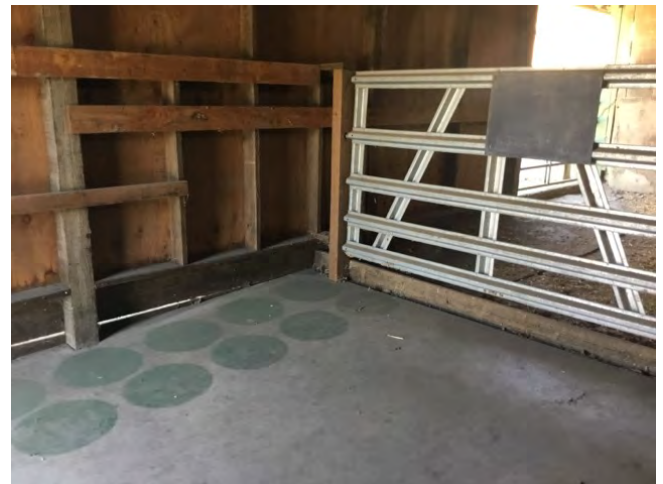
| 2424 | <ul style="list-style-type: none"> As-Built Description: Surface of required maneuvering clearance at door slopes more than 1/4":12" (2.0%). As-Built: 4.3% Proposed Solution: Modify surface slope at door. | PCODE ID11 ADAAG 91 4.13.6 ADA 2010 404.2.4.4 CBC 2007 1133B.2.4 CBC 2019 11B-404.2.4 | 60 | SF | \$120 | \$7,200 |

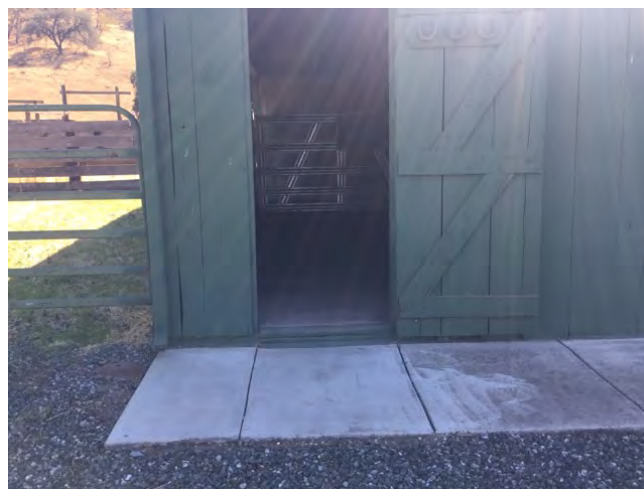
| Item no., Rm no. and Name | Existing Architectural Barrier and Proposed Solution | Codes / Mitigation Info | Qty | Unit | Cost | Total |
|---|---|---|---|---|---|--|
| 2425 | <ul style="list-style-type: none"> As-Built Description: Surface of required maneuvering clearance at door slopes more than 1/4":12" (2.0%). As-Built: 2.8%-4% Proposed Solution: Modify surface slope at door. | PCODE ID11 ADAAG 91 4.13.6 ADA 2010 404.2.4.4 CBC 2007 1133B.2.4 CBC 2019 11B-404.2.4 | 20 | SF | \$120 | \$2,400 |

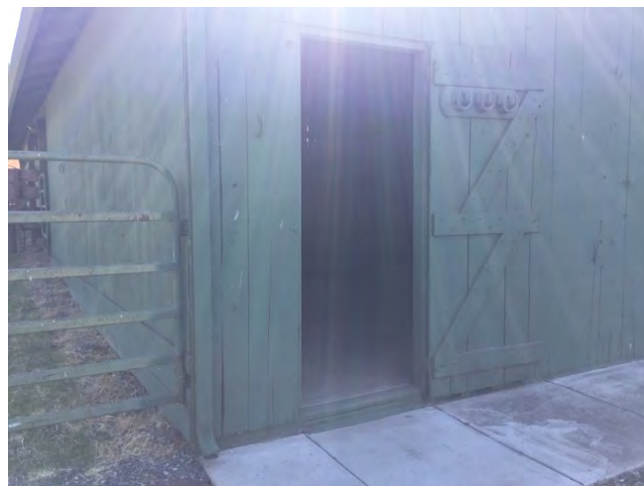
| 2422 | <ul style="list-style-type: none"> As-Built Description: Door inaccessible due to threshold or step at door exceeding 1/2". As-Built: 5" Proposed Solution: Modify threshold to be no more than 1/2" by removing existing paving at door and providing landing with edge ramping (slope 1:20 max). | PCODE ID02A ADAAG 91 4.13.8 ADA 2010 404.2.5 CBC 2007 1133B.2.4.1 CBC 2019 11B-404.2.5 | 1 | JOB | \$1,200 | \$1,200 |

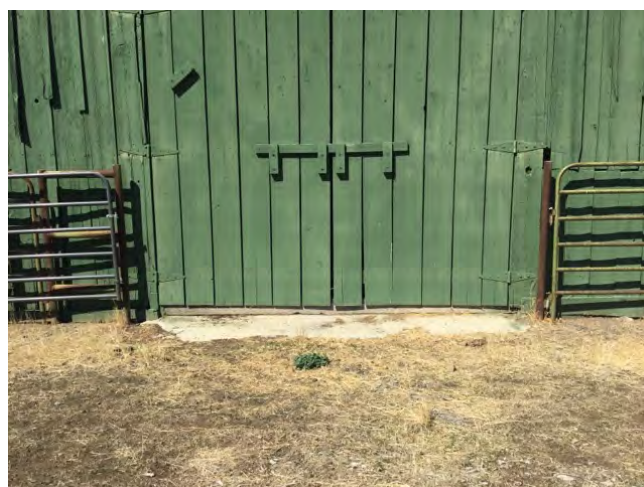
| 2430 | <ul style="list-style-type: none"> As-Built Description: Door inaccessible due to threshold or step at door exceeding 1/2". As-Built: 7" Proposed Solution: Modify threshold. | PCODE ID02A ADAAG 91 4.13.8 ADA 2010 404.2.5 CBC 2007 1133B.2.4.1 CBC 2019 11B-404.2.5 | 1 | JOB | \$1,200 | \$1,200 |
